Home Report

Bellwood House Cargates Madderty Crieff PH7 3PN

Single Survey

Survey report on:

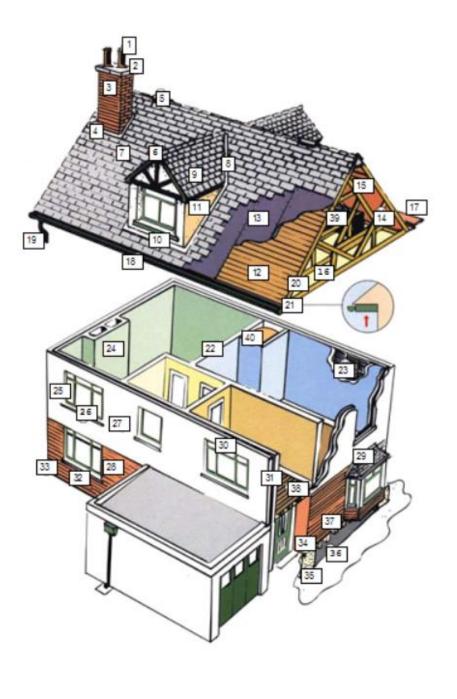
Sectional diagram showing elements of a typical house

Chimney pots 1 2 Coping stone 3 Chimney head 4 Flashing 5 **Ridge ventilation** 6 **Ridge board** 7 Slates / tiles 8 Valley guttering 9 Dormer projection 10 Dormer flashing Dormer cheeks 11 12 Sarking Roof felt 13 Trusses 14 15 Collar 16 Insulation 17 Parapet gutter 18 Eaves guttering 19 Rainwater downpipe 20 Verge boards / skews 21 Soffit boards Partition wall 22 23 Lath / plaster 24 Chimney breast 25 Window pointing Window sills 26 27 Rendering 28 Brickwork / pointing 29 Bay window projection 30 Lintels 31 Cavity walls / wall ties 32 Subfloor ventilator 33 Damp proof course 34 Base course 35 Foundations 36 Solum Floor joists 37 38 Floorboards 39 Water tank 40 Hot water tank

Reference may be made in this report to some or all of the above component parts of the property. This diagram may assist you in locating and understanding these items.

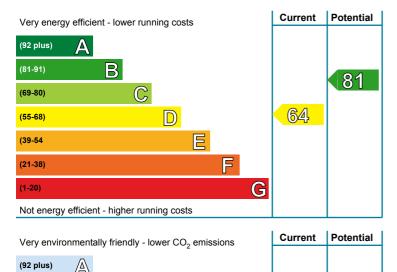
Energy Efficiency Rating

This graph shows the current efficiency of your home, taking into account both energy efficiency and fuel costs. The higher this rating, the lower your fuel bills are likely to be.
