HOME REPORT

Energy Performance Certificate (EPC)

BUSHES CROFT, WIGTOWN ROAD, SORBIE, NEWTON STEWART, DG8 8EL

survey report on:

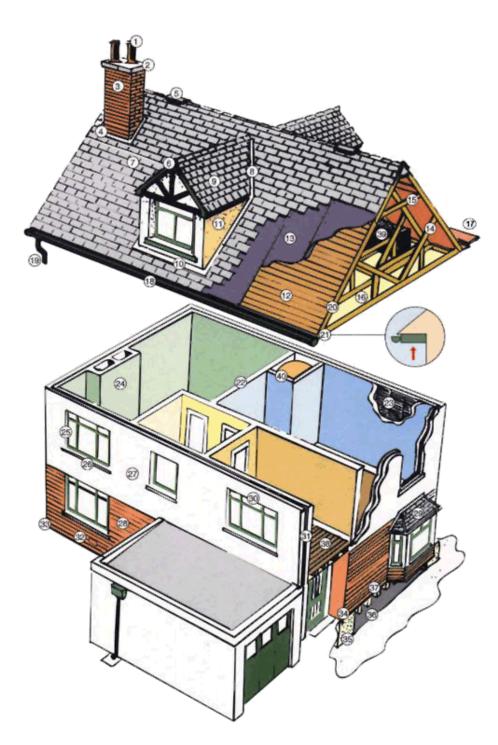
Sectional Diagram showing elements of a typical house

Reference may be made in this report to some or all of the above component parts of the property. This diagram may assist you in locating and understanding these items.

- 1) Chimney pots
- 2) Coping stone
- 3) Chimney head
- 4 Flashing
- 5 Ridge ventilation
- 6) Ridge board
- 7) Slates / tiles
- 8 Valley guttering
- 9 Dormer projection
- 10 Dormer flashing
- 11) Dormer cheeks
- 12) Sarking
- (13) Roof felt
- (14) Trusses
- (15) Collar
- (16) Insulation
- (17) Parapet gutter
- 18) Eaves guttering
- Rainwater downpipe
- 20) Verge boards /skews
- 21) Soffit boards
- 22) Partition wall
- 23) Lath / plaster
- 24) Chimney breast
- (25) Window pointing
 - 6) Window sills
- 27) Rendering
- (28) Brickwork / pointing
- 29) Bay window projection
- 30 Lintels
- (31) Cavity walls / wall ties
- 32) Subfloor ventilator
- 33 Damp proof course
- 34) Base course
- 35) Foundations
- 36) Solum
- 37) Floor joists
- 38 Floorboards
- 39) Water tank
- 40 Hot water tank
