HOME REPORT

2 OAKWOOD COTTAGES
SELKIRK
TD7 5HJ

Energy Performance Certificate (EPC)

Single Survey

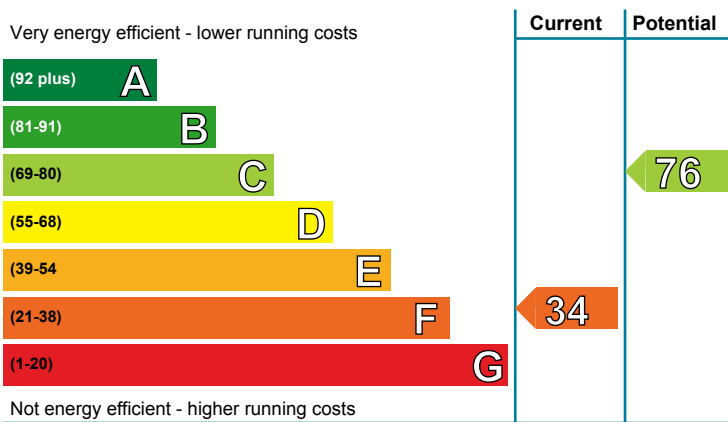
Energy Efficiency Rating

This graph shows the current efficiency of your home, taking into account both energy efficiency and fuel costs. The higher this rating, the lower your fuel bills are likely to be.

Your current rating is **band F (34)**. The average rating for EPCs in Scotland is **band D (61)**.

The potential rating shows the effect of undertaking all of the improvement measures listed within your recommendations report.

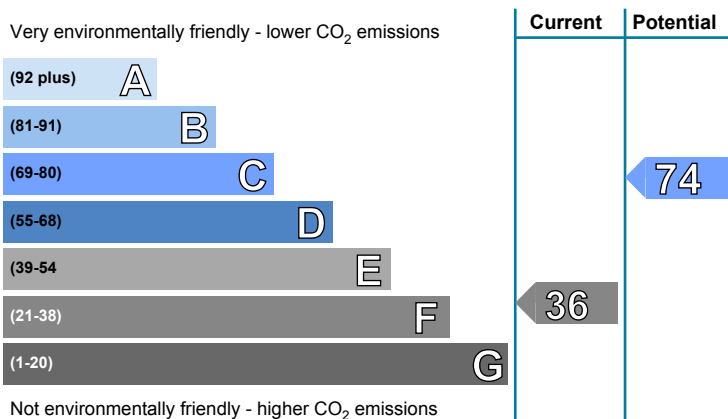
Environmental Impact (CO₂) Rating

This graph shows the effect of your home on the environment in terms of carbon dioxide (CO₂) emissions. The higher the rating, the less impact it has on the environment.

Your current rating is **band F (36)**. The average rating for EPCs in Scotland is **band D (59)**.

The potential rating shows the effect of undertaking all of the improvement measures listed within your recommendations report.
