HOME REPORT

1 OAKWOOD COTTAGES
SELKIRK
TD7 5HJ

Energy Performance Certificate (EPC)

Single Survey

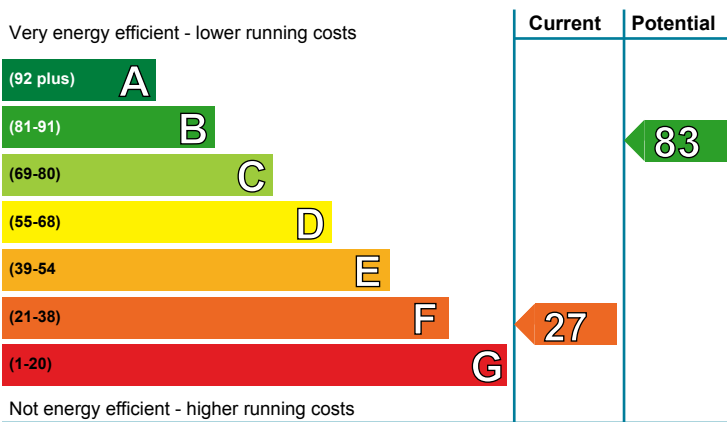
Energy Efficiency Rating

This graph shows the current efficiency of your home, taking into account both energy efficiency and fuel costs. The higher this rating, the lower your fuel bills are likely to be.

Your current rating is **band F (27)**. The average rating for EPCs in Scotland is **band D (61)**.

The potential rating shows the effect of undertaking all of the improvement measures listed within your recommendations report.

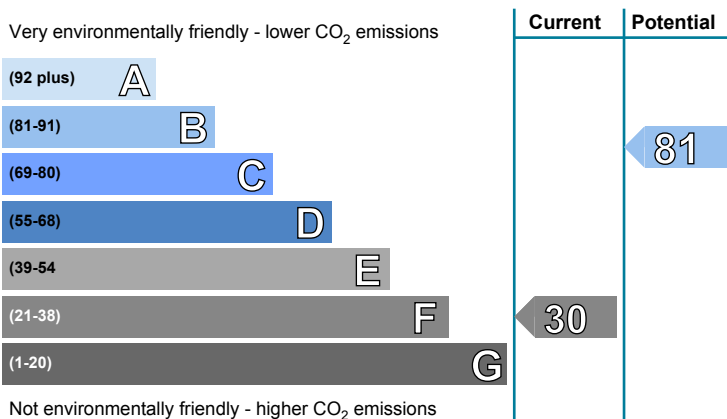
Environmental Impact (CO₂) Rating

This graph shows the effect of your home on the environment in terms of carbon dioxide (CO₂) emissions. The higher the rating, the less impact it has on the environment.

Your current rating is **band F (30)**. The average rating for EPCs in Scotland is **band D (59)**.

The potential rating shows the effect of undertaking all of the improvement measures listed within your recommendations report.
