# Home Report

# Scottish Single Survey

| Property address | The Red Myre<br>14 Arthurstone House<br>Meigle<br>PH12 8QW |

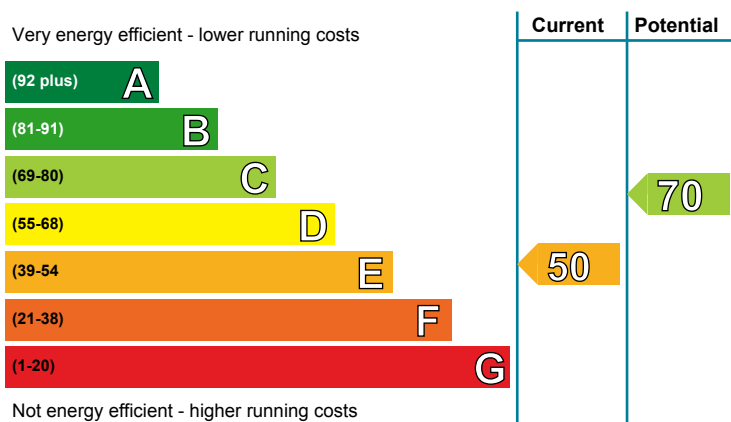
## Energy Efficiency Rating

This graph shows the current efficiency of your home, taking into account both energy efficiency and fuel costs. The higher this rating, the lower your fuel bills are likely to be.

Your current rating is **band E (50)**. The average rating for EPCs in Scotland is **band D (61)**.

The potential rating shows the effect of undertaking all of the improvement measures listed within your recommendations report.

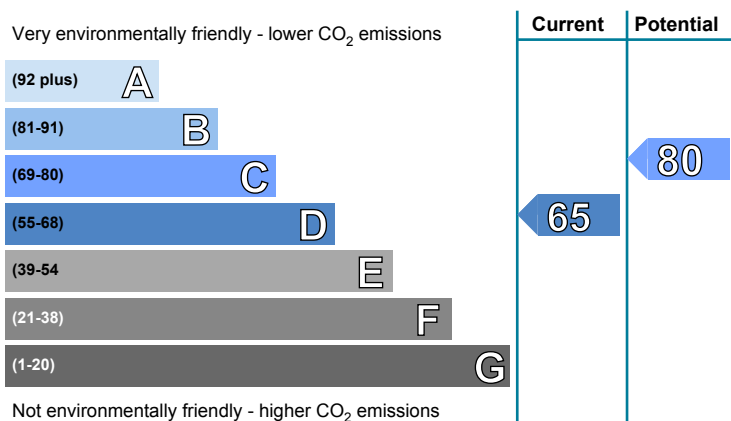
## Environmental Impact (CO<sub>2</sub>) Rating

This graph shows the effect of your home on the environment in terms of carbon dioxide (CO<sub>2</sub>) emissions. The higher the rating, the less impact it has on the environment.
