Home Report

46 High Street
Fortrose
IV10 8TF

single survey

survey report on:

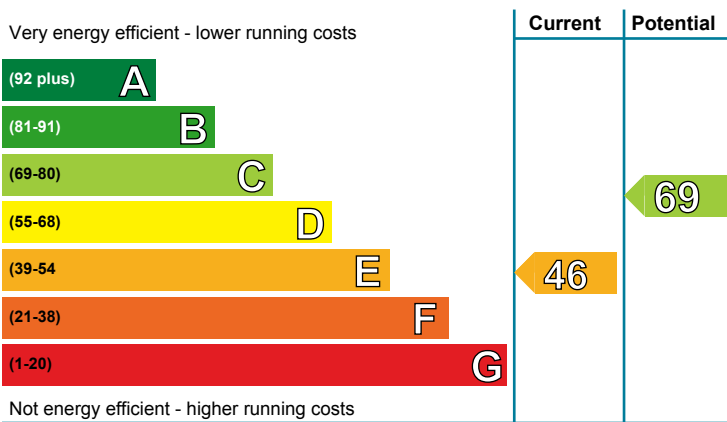
Energy Efficiency Rating

This graph shows the current efficiency of your home, taking into account both energy efficiency and fuel costs. The higher this rating, the lower your fuel bills are likely to be.

Your current rating is **band E (46)**. The average rating for EPCs in Scotland is **band D (61)**.

The potential rating shows the effect of undertaking all of the improvement measures listed within your recommendations report.

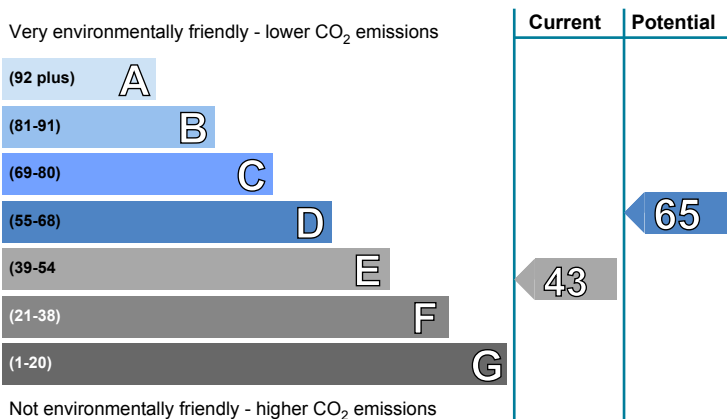
Environmental Impact (CO₂) Rating

This graph shows the effect of your home on the environment in terms of carbon dioxide (CO₂) emissions. The higher the rating, the less impact it has on the environment.
