Energy Performance Certificate (EPC)

UPPER BRANDSMYRES, BANCHORY DEVENICK, ABERDEEN, AB12 5XQ

Dwelling type:Detached houseDate of assessment:15 May 2023Date of certificate:18 May 2023

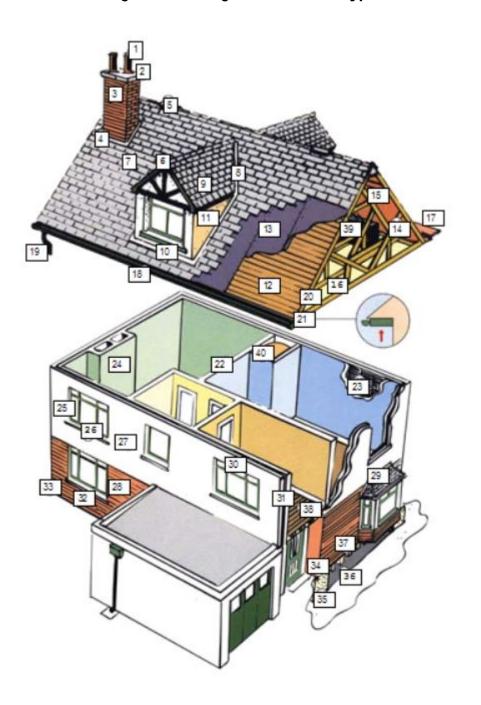
Sectional Diagram showing elements of a typical house

2 Coping stone 3 Chimney head Flashing 4 Ridge ventilation 5 Ridge board Slates/tiles 8 Valley guttering 9 Dormer projection Dormer flashing 10 Dormer cheeks 11 12 Sarking Roof felt 13 Trusses 14 15 Collar 16 Insulation 17 Parapet gutter Eaves guttering 18 Rainwater downpipe 19 20 Verge boards / skews 21 Soffit boards 22 Partition wall Lath / plaster 23 24 Chimney breast 25 Window pointing Window sills 26 27 Rendering Brickwork / pointing 28
