Home Report

Single Survey

Property address	Eglingham Main Street Gordon TD3 6JW
Customer	Ms Jane Scott
Customer address	Eglingham Main Street Gordon TD3 6JW
Prepared by	Shepherd Chartered Surveyors
Date of inspection	01/06/2026

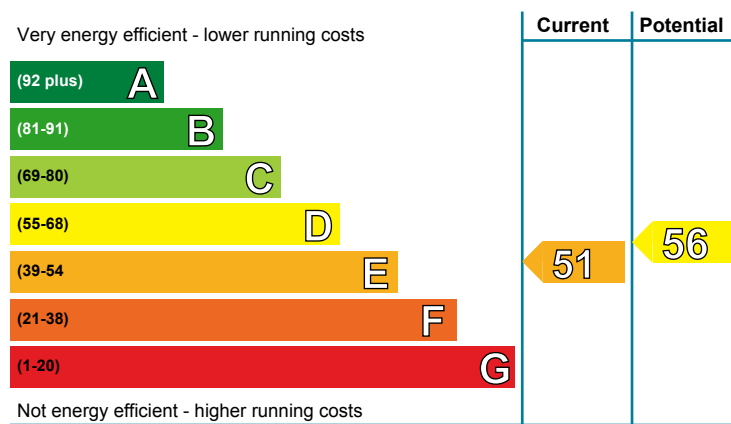
Energy Efficiency Rating

This graph shows the current efficiency of your home, taking into account both energy efficiency and fuel costs. The higher this rating, the lower your fuel bills are likely to be.

Your current rating is **band E (51)**. The average rating for EPCs in Scotland is **band D (61)**.

The potential rating shows the effect of undertaking all of the improvement measures listed within your recommendations report.

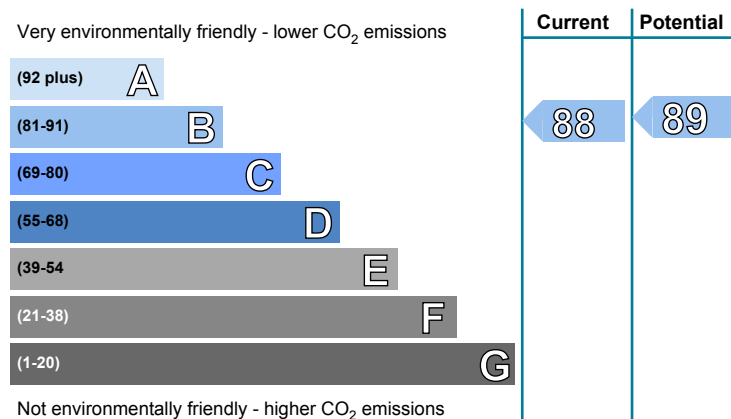
Environmental Impact (CO₂) Rating

This graph shows the effect of your home on the environment in terms of carbon dioxide (CO₂) emissions. The higher the rating, the less impact it has on the environment.
