4 Miners Row,
,
Ballygrant,
ISLE OF ISLAY,
PA45 7QR

Home Report

Single Survey

Survey Report on:

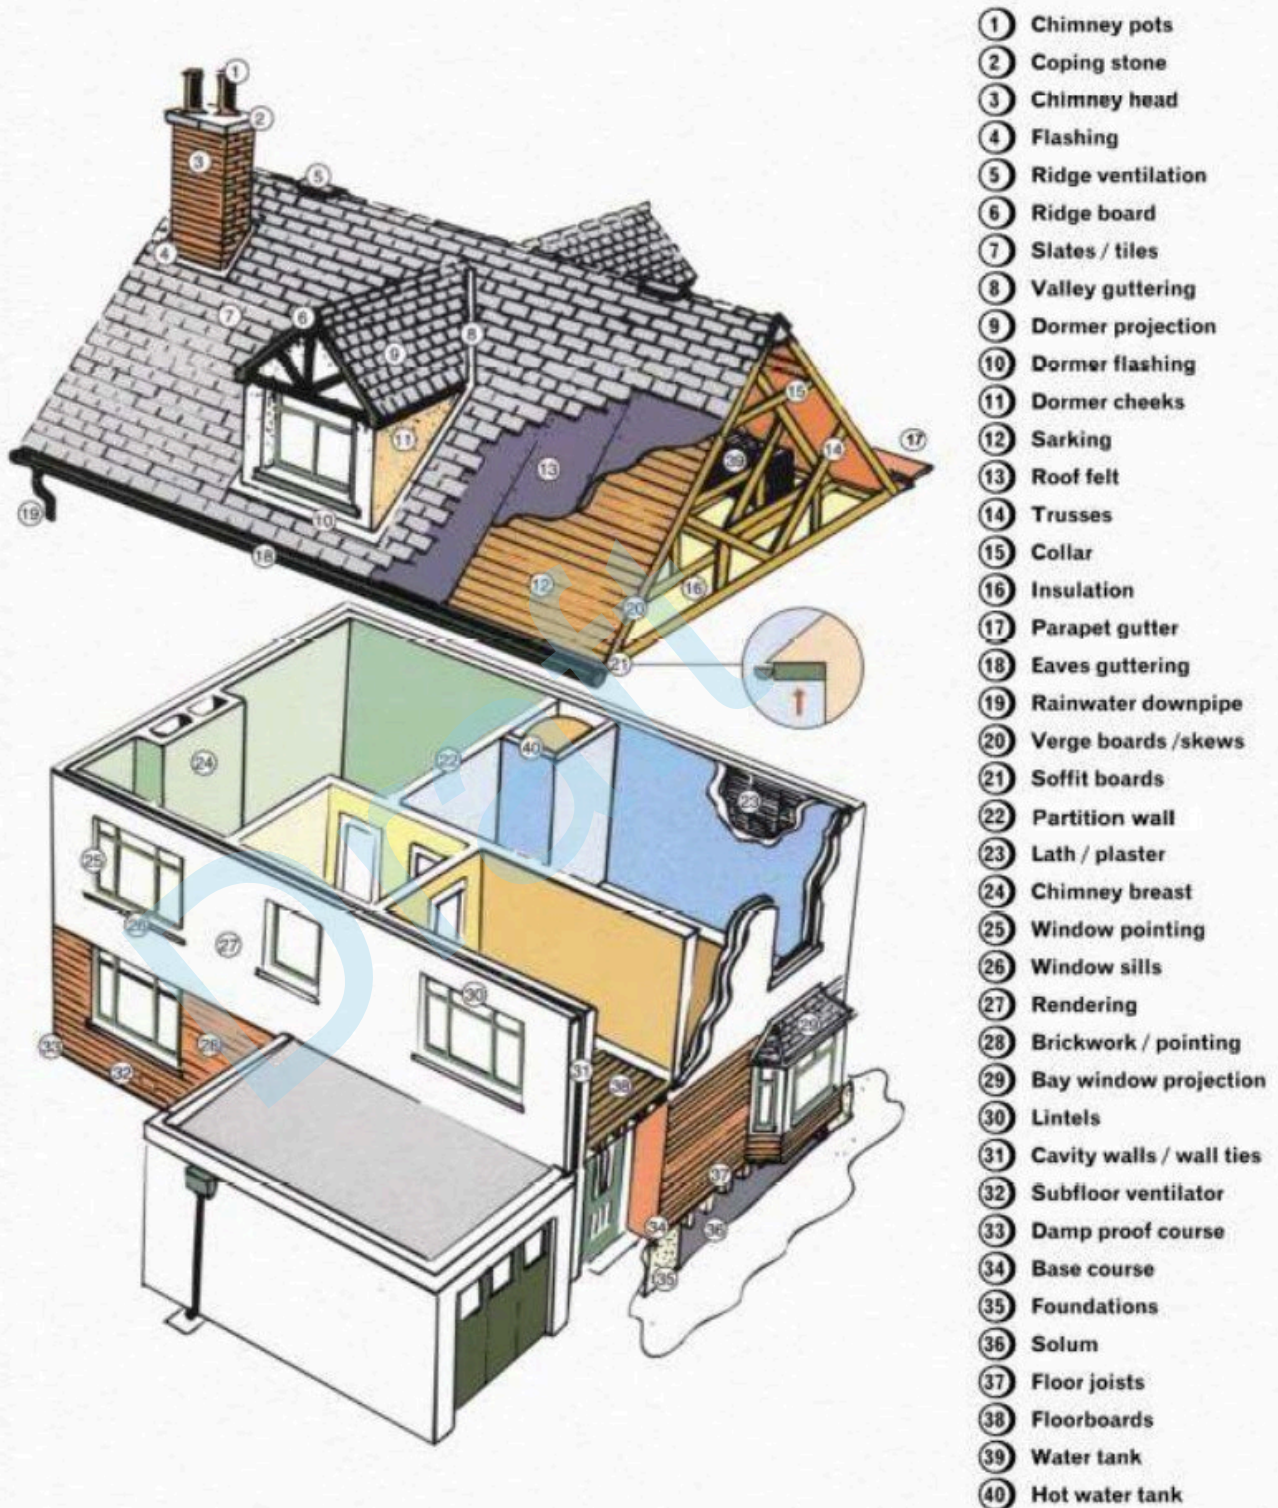
Sectional Diagram showing elements of a typical house

Reference may be made in this report to some or all of the above component parts of the property. This diagram may assist you in locating and understanding these items.
