Home Report

Scottish Single Survey

Property address	Countesswells House North Bielside Aberdeen AB15 9BT
-------------------------	---

Prepared by	Shepherd Chartered Surveyors
--------------------	------------------------------

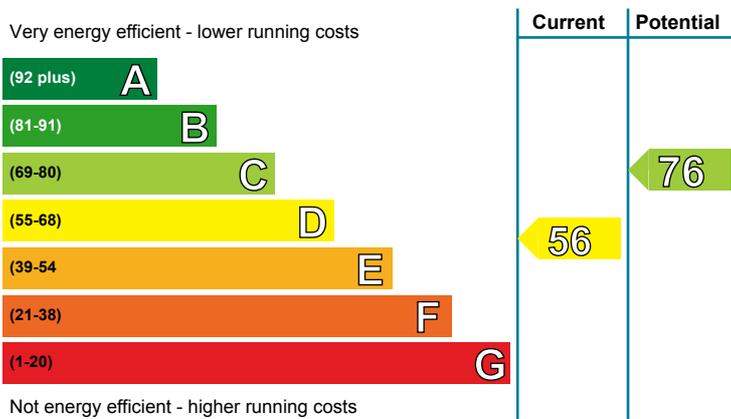
Energy Efficiency Rating

This graph shows the current efficiency of your home, taking into account both energy efficiency and fuel costs. The higher this rating, the lower your fuel bills are likely to be.

Your current rating is **band D (56)**. The average rating for EPCs in Scotland is **band D (61)**.

The potential rating shows the effect of undertaking all of the improvement measures listed within your recommendations report.
