Home Report

4 Mercer Green Meikleour PH2 6ER

single survey

survey report on:

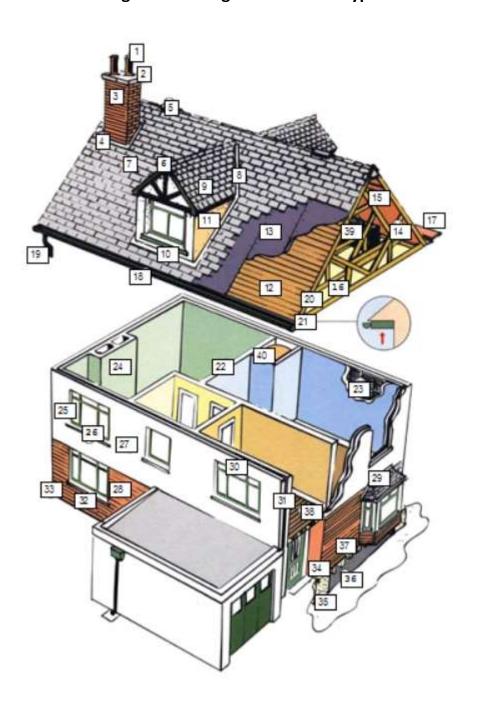
Sectional Diagram showing elements of a typical house

Reference may be made in this report to some or all of the above component parts of the property. This diagram may assist you in locating and understanding these items.

_
Chimney pots
Coping stone
Chimney head
Flashing
Ridge ventilation
Ridge board
Slates/tiles
Valley guttering
Dormer projection
Dormer flashing
Dormer cheeks
Sarking
Roof felt
Trusses
Collar
Insulation
Parapet gutter
Eaves guttering
Rainwater downpipe
Verge boards / skews
Soffit boards
Partition wall
Lath / plaster
Chimney breast
Window pointing
Window sills
Rendering
Brickwork / pointing
Bay window
Lintels
Cavity walls / wall ties
Subfloor ventilator
Damp proof course
Base course
Foundations
