# Home Report

# Scottish Single Survey

Property address	Balgowan Farmhouse Ardwell Stranraer DG9 9NB
Customer	Lady Angela Buchan-Hepburn
Customer address	
Prepared by	Shepherd Chartered Surveyors
Date of inspection	29/11/2023

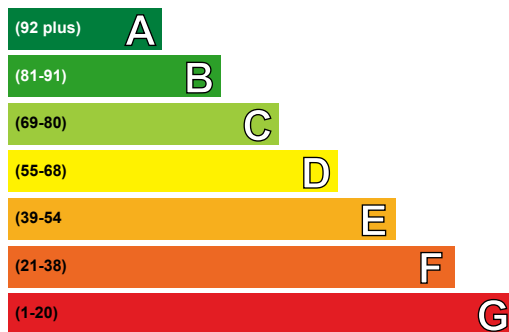
## Energy Efficiency Rating

Current	Potential
40	61

The potential rating shows the effect of undertaking all of the improvement measures listed within your recommendations report.

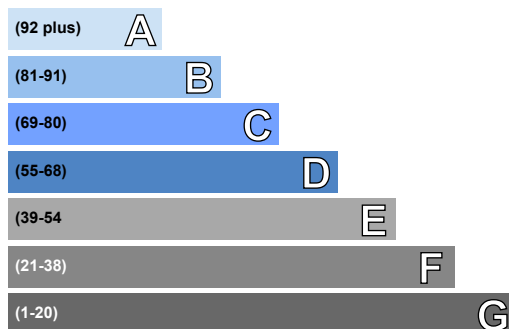
## Environmental Impact (CO<sub>2</sub>) Rating

Current	Potential
34	59
