Home Report

Single Survey

Property Address	The Red House, Heughhead, Strathdon, AB36 8XJ
Customer	Ms Mahri Prince
Date of Inspection	26/03/2026
Prepared by	Ryan Stewart Walker Fraser Steele

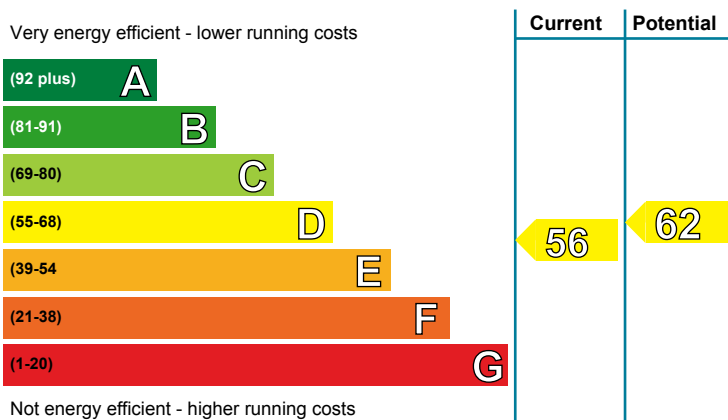
Energy Efficiency Rating

This graph shows the current efficiency of your home, taking into account both energy efficiency and fuel costs. The higher this rating, the lower your fuel bills are likely to be.

Your current rating is **band D (56)**. The average rating for EPCs in Scotland is **band D (61)**.

The potential rating shows the effect of undertaking all of the improvement measures listed within your recommendations report.

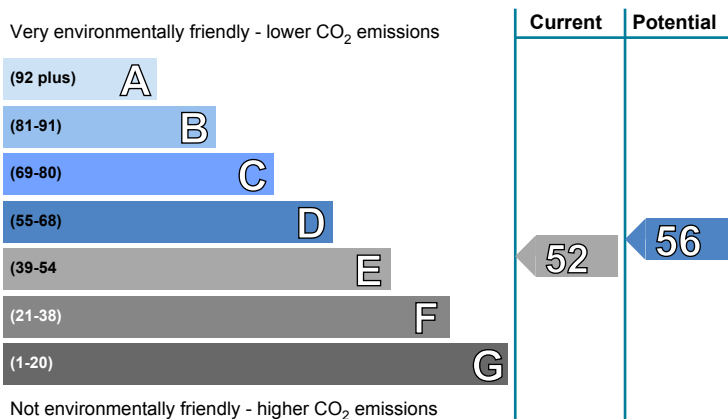
Environmental Impact (CO₂) Rating

This graph shows the effect of your home on the environment in terms of carbon dioxide (CO₂) emissions. The higher the rating, the less impact it has on the environment.
