Home Report

Gardeners Cottage
Easter Skene
Skene
Westhill
AB32 6YB

single survey

Property address	Gardeners Cottage Easter Skene Skene Westhill AB32 6YB
Customer	Mr George F Pearson
Prepared by	Graham + Sibbald LLP

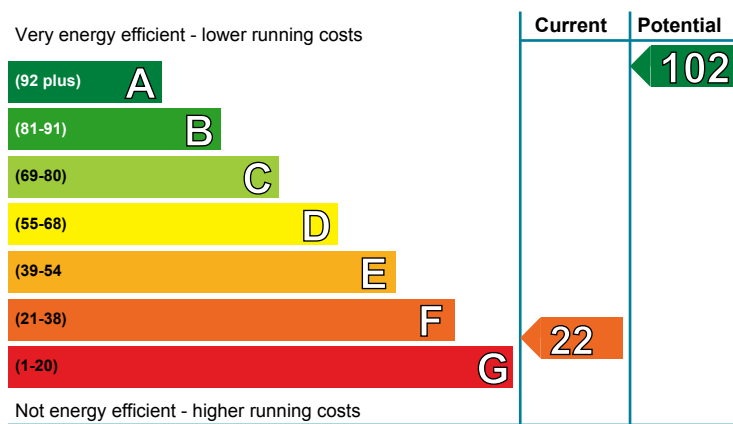
Energy Efficiency Rating

This graph shows the current efficiency of your home, taking into account both energy efficiency and fuel costs. The higher this rating, the lower your fuel bills are likely to be.

Your current rating is **band F (22)**. The average rating for EPCs in Scotland is **band D (61)**.

The potential rating shows the effect of undertaking all of the improvement measures listed within your recommendations report.
