YOUR ONESURVEY  
**HOME REPORT**

Lentran Lea  
Lentran, Inverness  
IV3 8RL

# SINGLE SURVEY

# Single Survey

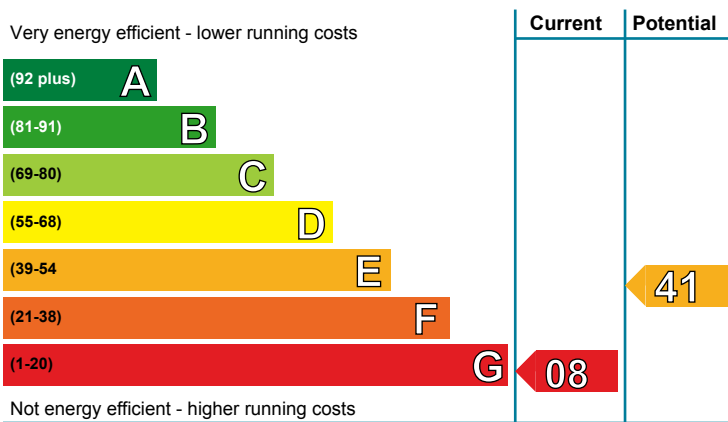
## Energy Efficiency Rating

This graph shows the current efficiency of your home, taking into account both energy efficiency and fuel costs. The higher this rating, the lower your fuel bills are likely to be.

Your current rating is **band G (8)**. The average rating for EPCs in Scotland is **band D (61)**.

The potential rating shows the effect of undertaking all of the improvement measures listed within your recommendations report.

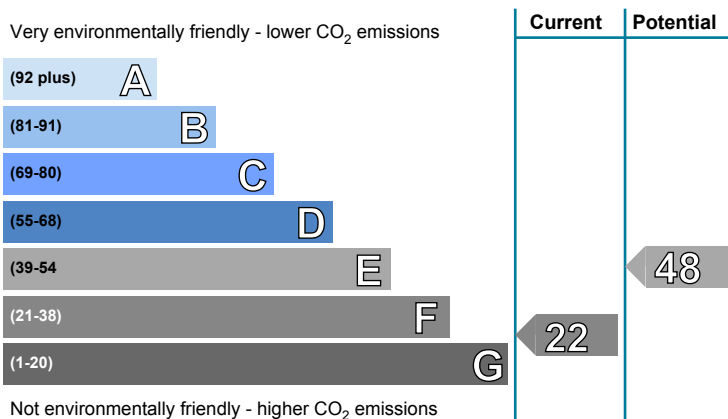
## Environmental Impact (CO<sub>2</sub>) Rating

This graph shows the effect of your home on the environment in terms of carbon dioxide (CO<sub>2</sub>) emissions. The higher the rating, the less impact it has on the environment.
