Home Report

Scottish
Single Survey

Property address	Upper Glenlair Knockvennie Castle Douglas DG7 3NT
Customer	Gordon Scott
Customer address	Upper Glenlair Knockvennie Castle Douglas DG7 3NT
Prepared by	Shepherd Chartered Surveyors
Date of inspection	15/09/2025

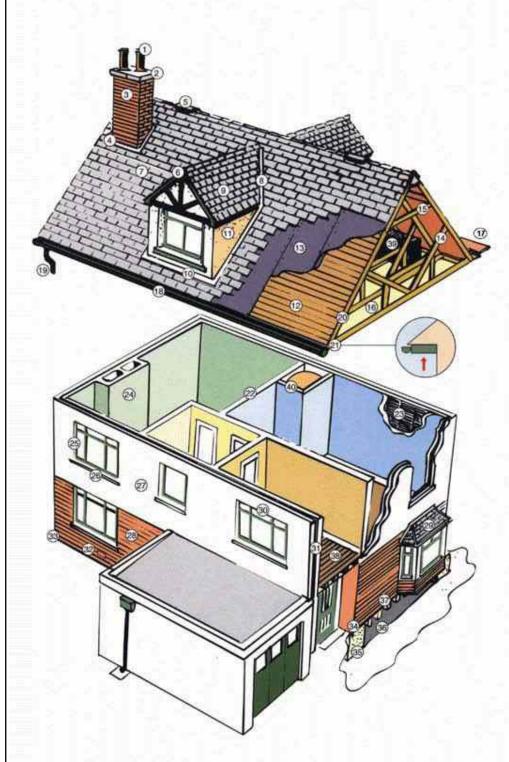
Sectional Diagram showing elements of a typical house

Reference may be made in this report to some or all of the above component parts of the property. This diagram may assist you in locating and understanding these items.

- (1) Chimney pots
- 2) Coping stone
- 3 Chimney head
- (4) Flashing
- 5) Ridge ventilation
- 6 Ridge board
- (7) Slates / tiles
- 8 Valley guttering
- Dormer projection
- 10 Dormer flashing
- 11) Dormer cheeks
- (12) Sarking
- 13) Roof felt
- (14) Trusses
- (15) Collar
- (16) Insulation
- (17) Parapet gutter
- 18) Eaves guttering
- (19) Rainwater downpipe
- 20) Verge boards /skews
- 21) Soffit boards
- 22) Partition wall
- (23) Lath / plaster
- (24) Chimney breast
- (25) Window pointing
- 26) Window sills
- 27) Rendering
- (28) Brickwork / pointing
- 29 Bay window projection
- (30) Lintels
- (31) Cavity walls / wall ties
- 32) Subfloor ventilator
- (33) Damp proof course
- (34) Base course
- 35) Foundations
- 36) Solum
- 37) Floor joists
- 38) Floorboards
- 39) Water tank
- 40) Hot water tank
