Home Report

Single Survey

Property address	Ayrlie 40 King Street Newton Stewart DG8 6DQ
Customer	Mr Jamie Hyslop & Mrs Karen Hyslop
Customer address	Ayrlie 40 King Street Newton Stewart DG8 6DQ
Prepared by	Shepherd Chartered Surveyors
Date of inspection	30/04/2026

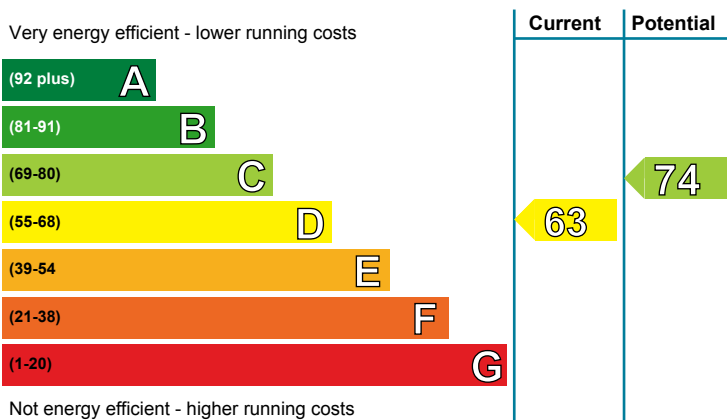
Energy Efficiency Rating

This graph shows the current efficiency of your home, taking into account both energy efficiency and fuel costs. The higher this rating, the lower your fuel bills are likely to be.

Your current rating is **band D (63)**. The average rating for EPCs in Scotland is **band D (61)**.

The potential rating shows the effect of undertaking all of the improvement measures listed within your recommendations report.

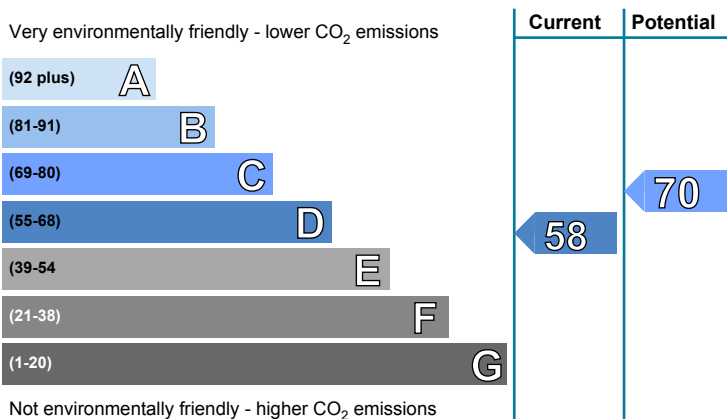
Environmental Impact (CO₂) Rating

This graph shows the effect of your home on the environment in terms of carbon dioxide (CO₂) emissions. The higher the rating, the less impact it has on the environment.
