Home Report

Scottish Single Survey

Property address	Oir Na Mara Barcaldine Oban PA37 1SE
-------------------------	---

Prepared by	Shepherd Chartered Surveyors
--------------------	------------------------------

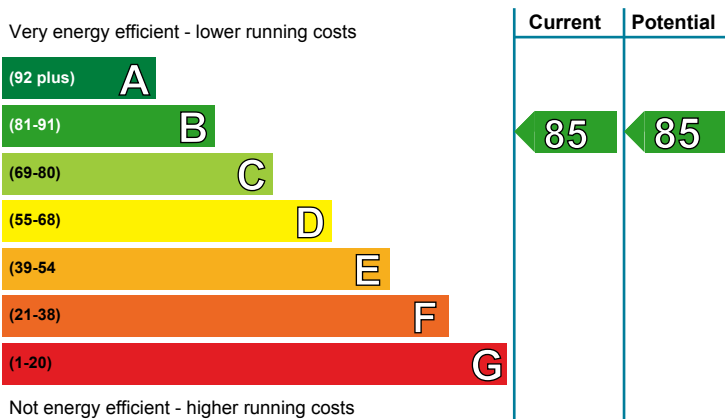
Energy Efficiency Rating

This graph shows the current efficiency of your home, taking into account both energy efficiency and fuel costs. The higher this rating, the lower your fuel bills are likely to be.

Your current rating is **band B (85)**. The average rating for EPCs in Scotland is **band D (61)**.

The potential rating shows the effect of undertaking all of the improvement measures listed within your recommendations report.

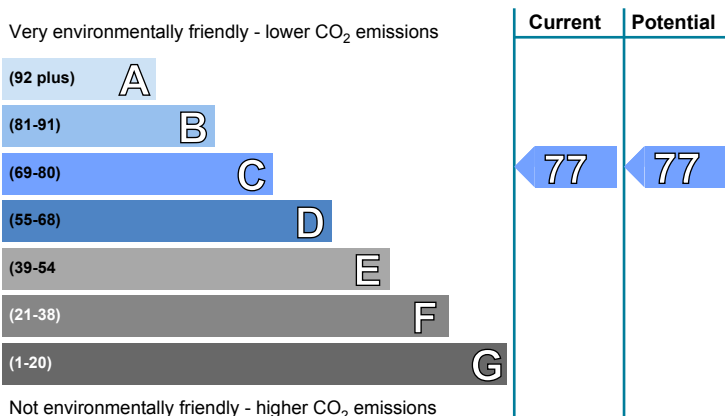
Environmental Impact (CO₂) Rating

This graph shows the effect of your home on the environment in terms of carbon dioxide (CO₂) emissions. The higher the rating, the less impact it has on the environment.
