## **SINGLE SURVEY REPORT**

**WHITELAW FARM  
BABERTON ROAD  
EH14 5AB**

**20<sup>TH</sup> FEBRUARY 2024**

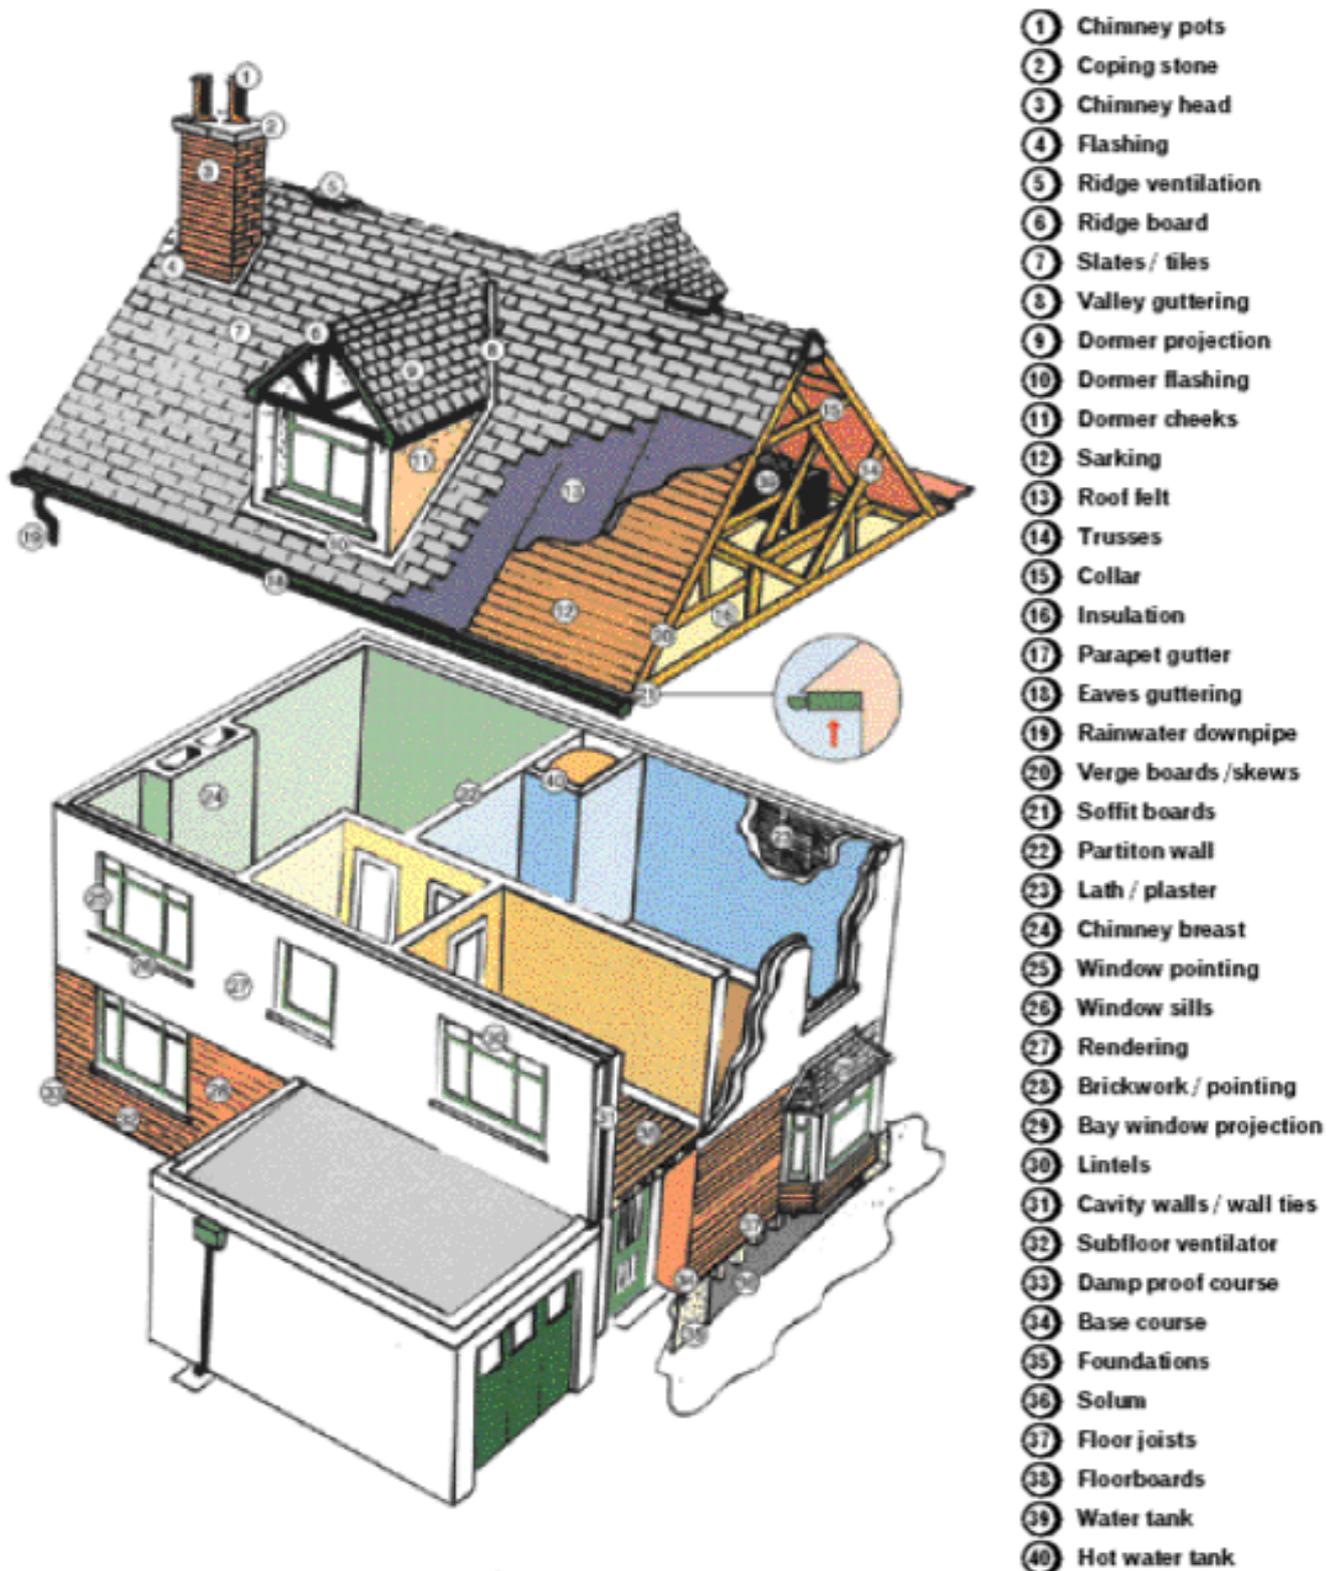
Sectional diagram showing elements of a typical house

Reference may be made in this report to some or all of the above component parts of the property. This diagram may assist you in locating and understanding these terms.

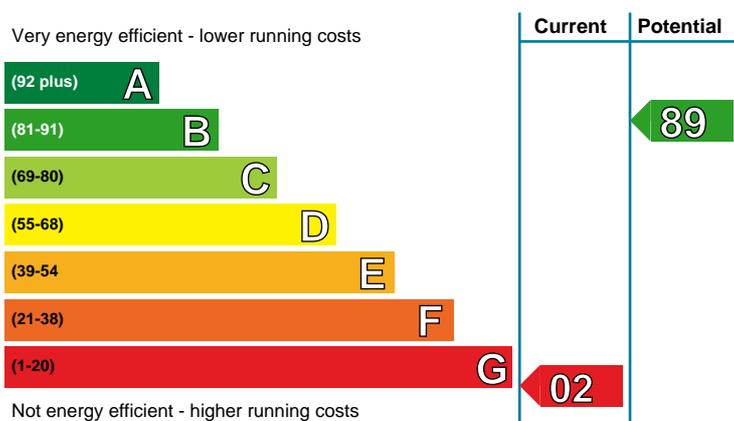
## Energy Efficiency Rating

This graph shows the current efficiency of your home, taking into account both energy efficiency and fuel costs. The higher this rating, the lower your fuel bills are likely to be.

Your current rating is **band G (2)**. The average rating for EPCs in Scotland is **band D (61)**.

The potential rating shows the effect of undertaking all of the improvement measures listed within your recommendations report.

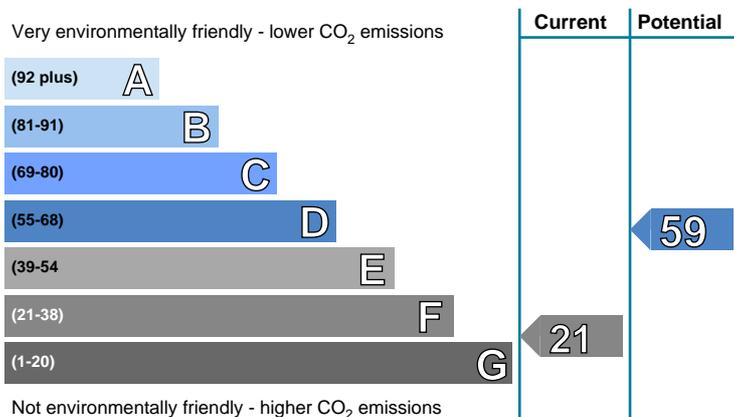
## Environmental Impact (CO<sub>2</sub>) Rating

This graph shows the effect of your home on the environment in terms of carbon dioxide (CO<sub>2</sub>) emissions. The higher the rating, the less impact it has on the environment.
