Home Report

Single Survey

Property address	Broomieholm Canonbie DG14 0XD
Customer	Buccleuch Estates Ltd
Customer address	Broomieholm Canonbie DG14 0XD
Prepared by	Shepherd Chartered Surveyors
Date of inspection	04/04/2025

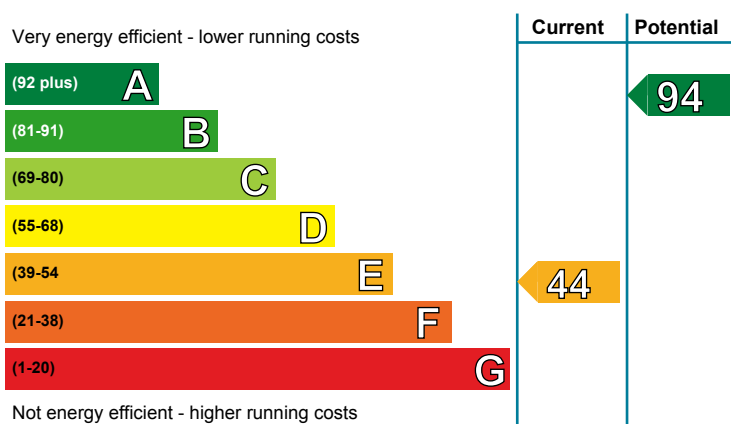
Energy Efficiency Rating

This graph shows the current efficiency of your home, taking into account both energy efficiency and fuel costs. The higher this rating, the lower your fuel bills are likely to be.

Your current rating is **band E (44)**. The average rating for EPCs in Scotland is **band D (61)**.

The potential rating shows the effect of undertaking all of the improvement measures listed within your recommendations report.

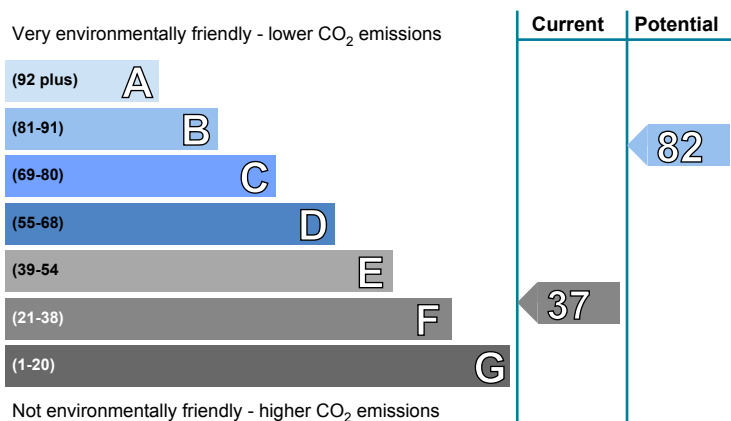
Environmental Impact (CO₂) Rating

This graph shows the effect of your home on the environment in terms of carbon dioxide (CO₂) emissions. The higher the rating, the less impact it has on the environment.
