# Home Report

# Scottish Single Survey

<b>Property address</b>	Dankeith Farm Symington Kilmarnock KA1 5SH
<b>Customer</b>	John Gray & Sons
<b>Customer address</b>	Craigs Farm Kilmarnock KA2 9AX
<b>Prepared by</b>	Shepherd Chartered Surveyors
<b>Date of inspection</b>	07/06/2023

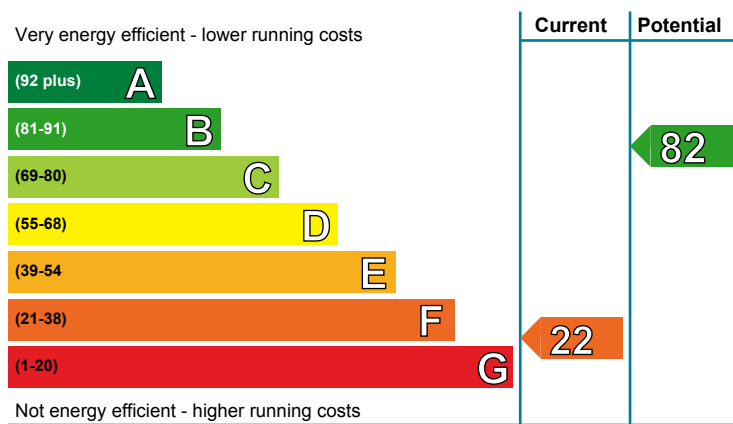
## Energy Efficiency Rating

This graph shows the current efficiency of your home, taking into account both energy efficiency and fuel costs. The higher this rating, the lower your fuel bills are likely to be.

Your current rating is **band F (22)**. The average rating for EPCs in Scotland is **band D (61)**.

The potential rating shows the effect of undertaking all of the improvement measures listed within your recommendations report.

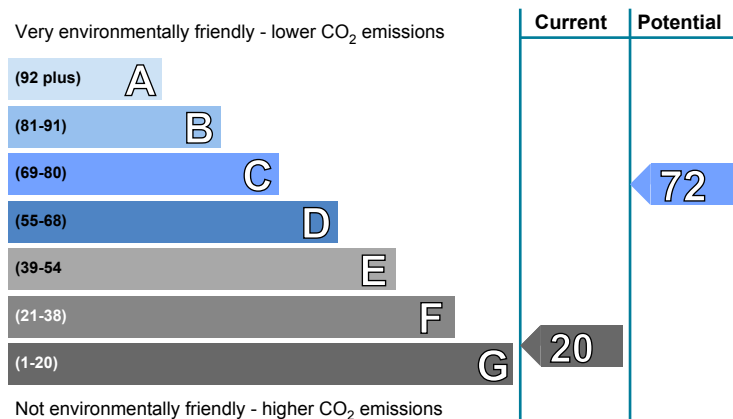
## Environmental Impact (CO<sub>2</sub>) Rating

This graph shows the effect of your home on the environment in terms of carbon dioxide (CO<sub>2</sub>) emissions. The higher the rating, the less impact it has on the environment.
