# Home Report

# Scottish Single Survey

<b>Property address</b>	Law Farm Tarbolton Mauchline KA5 5NB
<b>Customer</b>	Mr & Mrs Taylor
<b>Customer address</b>	Law Farm Tarbolton Mauchline KA5 5NB
<b>Prepared by</b>	Shepherd Chartered Surveyors
<b>Date of inspection</b>	22/08/2024

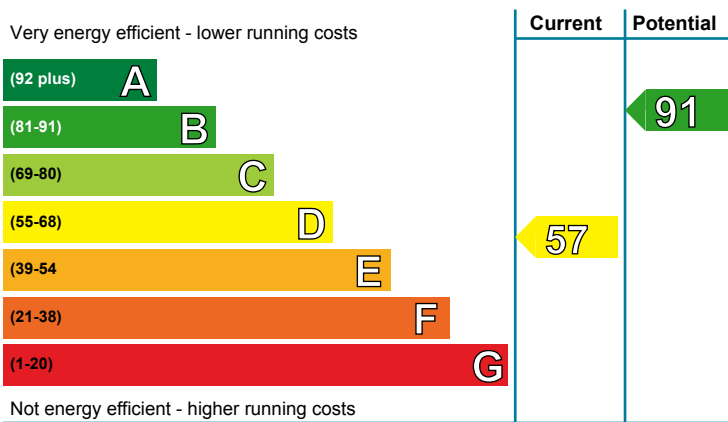
## Energy Efficiency Rating

This graph shows the current efficiency of your home, taking into account both energy efficiency and fuel costs. The higher this rating, the lower your fuel bills are likely to be.

Your current rating is **band D (57)**. The average rating for EPCs in Scotland is **band D (61)**.

The potential rating shows the effect of undertaking all of the improvement measures listed within your recommendations report.
