Home Report

Stormont House
11 Mansfield Road
Scone
PH2 6SA

single survey

Property address	Stormont House 11 Mansfield Road Scone PH2 6SA
Customer	Alan Stewart + Sally Begg
Prepared by	Graham + Sibbald LLP

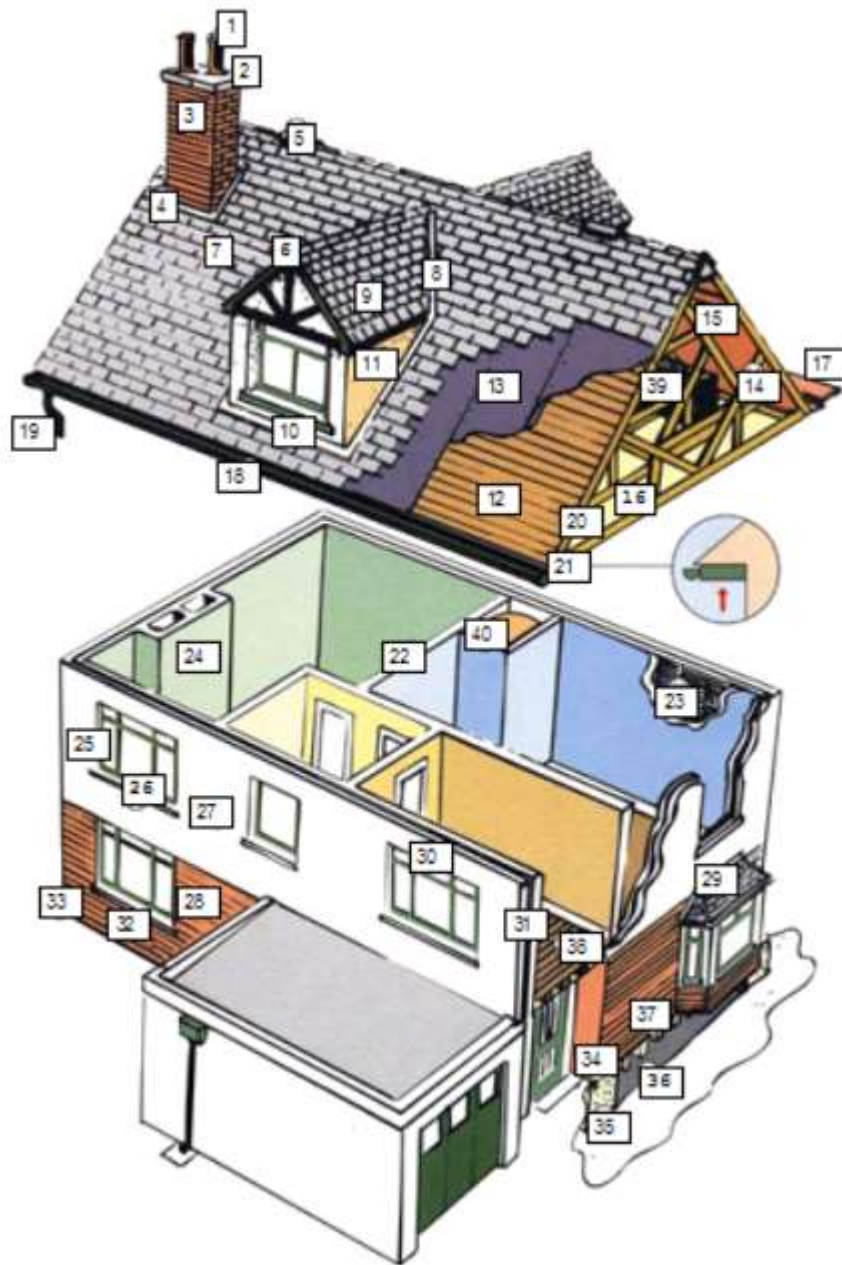
Sectional Diagram showing elements of a typical house

1	Chimney pots
2	Coping stone
3	Chimney head
4	Flashing
5	Ridge ventilation
6	Ridge board
7	Slates/tiles
8	Valley guttering
9	Dormer projection
10	Dormer flashing
11	Dormer cheeks
12	Sarking
13	Roof felt
14	Trusses
15	Collar
16	Insulation
17	Parapet gutter
18	Eaves guttering
19	Rainwater downpipe
20	Verge boards / skewes
21	Soffit boards
22	Partition wall
23	Lath / plaster
24	Chimney breast
25	Window pointing
26	Window sills
27	Rendering
28	Brickwork / pointing
29	Bay window
30	Lintels
31	Cavity walls / wall ties
32	Subfloor ventilator
33	Damp proof course
34	Base course
35	Foundations
36	Solum
37	Floor joists
38	Floorboards
39	Water tank
40	Hot water tank

Reference may be made in this report to some or all of the above component parts of the property. This diagram may assist you in locating and understanding these items.

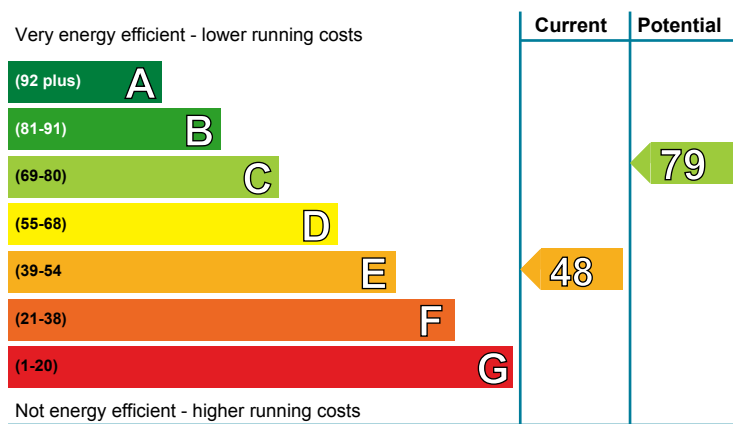
Energy Efficiency Rating

This graph shows the current efficiency of your home, taking into account both energy efficiency and fuel costs. The higher this rating, the lower your fuel bills are likely to be.

Your current rating is **band E (48)**. The average rating for EPCs in Scotland is **band D (61)**.

The potential rating shows the effect of undertaking all of the improvement measures listed within your recommendations report.
