YOUR ONESURVEY HOME REPORT

East Hillhead Farm
Mauchline
KA5 6HA

SINGLE SURVEY

Surveyor Reference	AE/4476
Customer	Mr. S Dick
Selling address	East Hillhead Farm Mauchline KA5 6HA
Date of Inspection	22/04/2025
Prepared by	Mark Shanks, BSc MRICS Ayr - Allied Surveyors Scotland Ltd

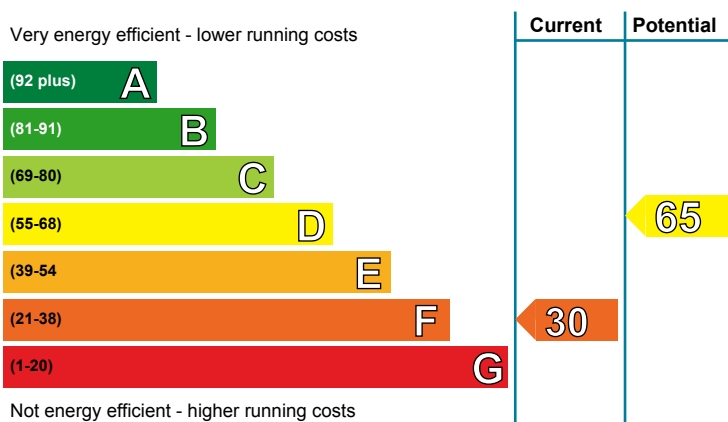
Energy Efficiency Rating

This graph shows the current efficiency of your home, taking into account both energy efficiency and fuel costs. The higher this rating, the lower your fuel bills are likely to be.

Your current rating is **band F (30)**. The average rating for EPCs in Scotland is **band D (61)**.

The potential rating shows the effect of undertaking all of the improvement measures listed within your recommendations report.

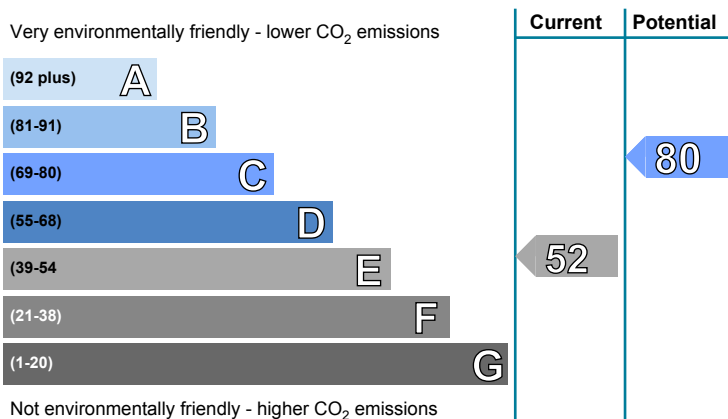
Environmental Impact (CO₂) Rating

This graph shows the effect of your home on the environment in terms of carbon dioxide (CO₂) emissions. The higher the rating, the less impact it has on the environment.
