# Home Report

44 Island Bank Road  
Inverness IV2 4QT

# single survey

Property address	44 Island Bank Road Inverness IV2 4QT
Customer	Moira Kerrison
Prepared by	Graham + Sibbald LLP

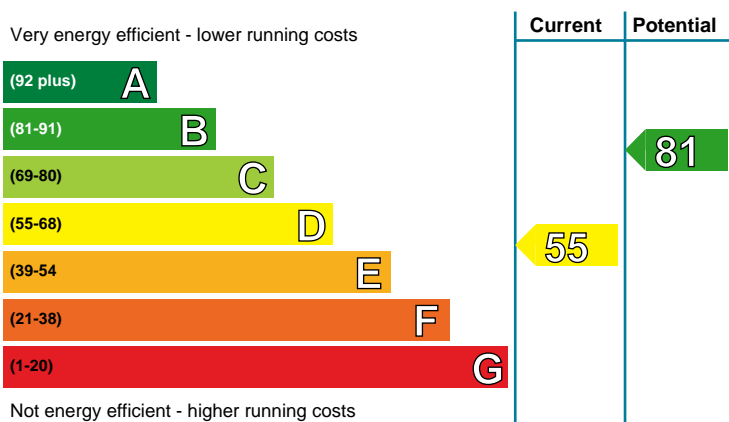
## Energy Efficiency Rating

This graph shows the current efficiency of your home, taking into account both energy efficiency and fuel costs. The higher this rating, the lower your fuel bills are likely to be.

Your current rating is **band D (55)**. The average rating for EPCs in Scotland is **band D (61)**.

The potential rating shows the effect of undertaking all of the improvement measures listed within your recommendations report.

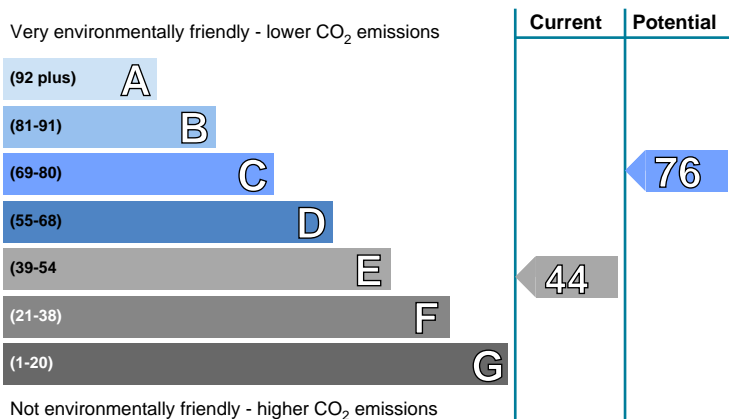
## Environmental Impact (CO<sub>2</sub>) Rating

This graph shows the effect of your home on the environment in terms of carbon dioxide (CO<sub>2</sub>) emissions. The higher the rating, the less impact it has on the environment.
