Home Report

Single Survey

Property address	Craig Villa Guest House Dalmally PA33 1AX
Customer	Mr Ewan Diven
Customer address	Craig Villa Guest House Dalmally PA33 1AX
Prepared by	Shepherd Chartered Surveyors
Date of inspection	28/01/2026

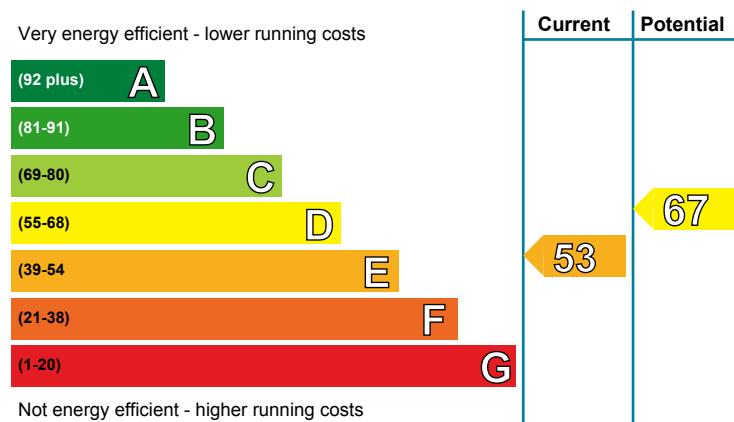
Energy Efficiency Rating

This graph shows the current efficiency of your home, taking into account both energy efficiency and fuel costs. The higher this rating, the lower your fuel bills are likely to be.

Your current rating is **band E (53)**. The average rating for EPCs in Scotland is **band D (61)**.

The potential rating shows the effect of undertaking all of the improvement measures listed within your recommendations report.

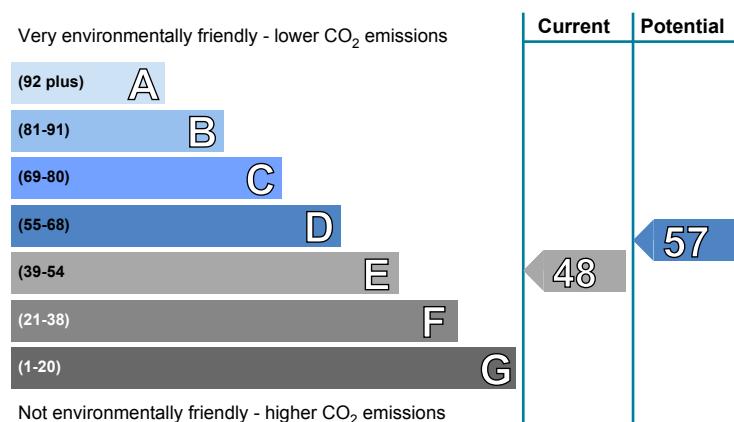
Environmental Impact (CO₂) Rating

This graph shows the effect of your home on the environment in terms of carbon dioxide (CO₂) emissions. The higher the rating, the less impact it has on the environment.
