YOUR ONESURVEY  
**HOME REPORT**

The Croft, 10 Institution Road  
Elgin  
IV30 1QX

# SINGLE SURVEY

A report on the condition of the property, with categories being rated from 1 to 3.

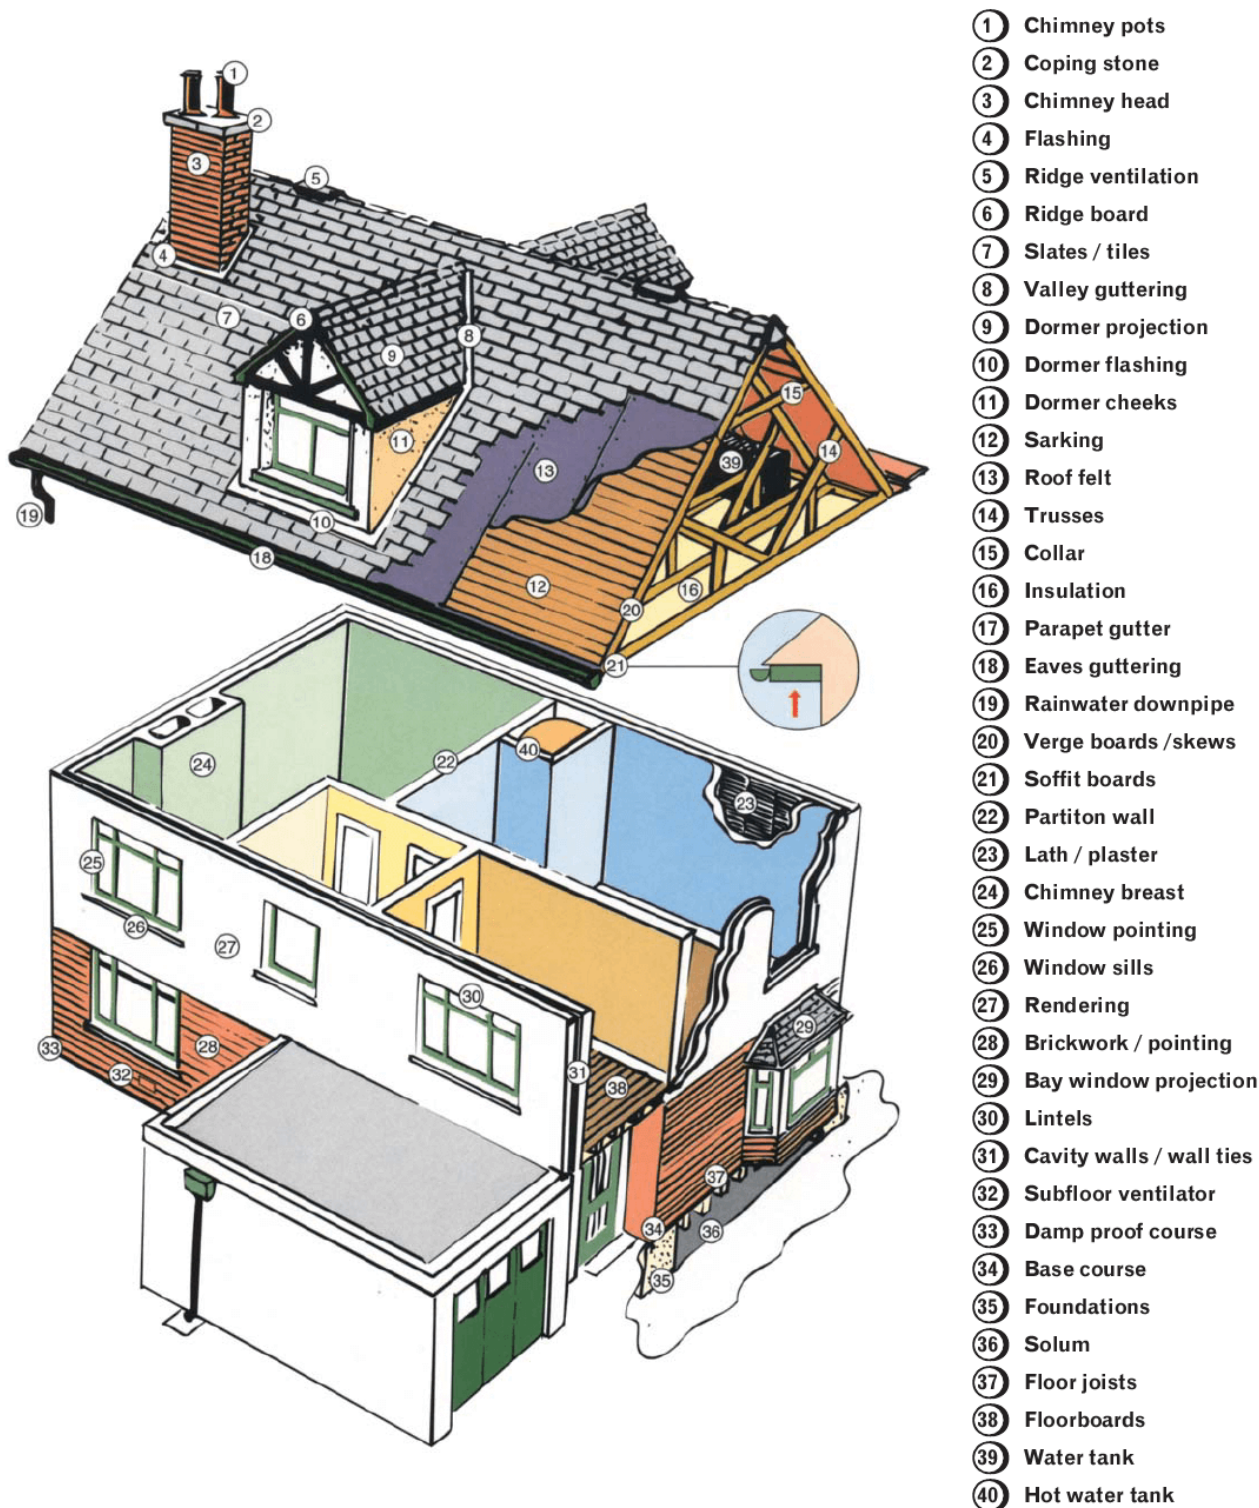
## Sectional Diagram showing elements of a typical house

- ① Chimney pots
- ② Coping stone
- ③ Chimney head
- ④ Flashing
- ⑤ Ridge ventilation
- ⑥ Ridge board
- ⑦ Slates / tiles
- ⑧ Valley guttering
- ⑨ Dormer projection
- ⑩ Dormer flashing
- ⑪ Dormer cheeks
- ⑫ Sarking
- ⑬ Roof felt
- ⑭ Trusses
- ⑮ Collar
- ⑯ Insulation
- ⑰ Parapet gutter
- ⑱ Eaves guttering
- ⑲ Rainwater downpipe
- ⑳ Verge boards /skews
- ㉑ Soffit boards
- ㉒ Partiton wall
- ㉓ Lath / plaster
- ㉔ Chimney breast
- ㉕ Window pointing
- ㉖ Window sills
- ㉗ Rendering
- ㉘ Brickwork / pointing
- ㉙ Bay window projection
- ㉚ Lintels
- ㉛ Cavity walls / wall ties
- ㉜ Subfloor ventilator
- ㉝ Damp proof course
- ㉞ Base course
- ㉟ Foundations
- ㊱ Solum
- ㊲ Floor joists
- ㊳ Floorboards
- ㊴ Water tank
- ㊵ Hot water tank

Reference may be made in this report to some or all of the above component parts of the property. This diagram may assist you in locating and understanding these items.

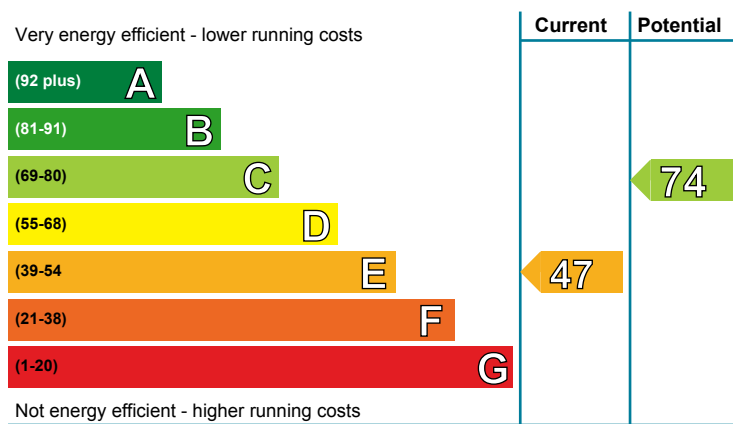
## Energy Efficiency Rating

This graph shows the current efficiency of your home, taking into account both energy efficiency and fuel costs. The higher this rating, the lower your fuel bills are likely to be.

Your current rating is **band E (47)**. The average rating for EPCs in Scotland is **band D (61)**.

The potential rating shows the effect of undertaking all of the improvement measures listed within your recommendations report.

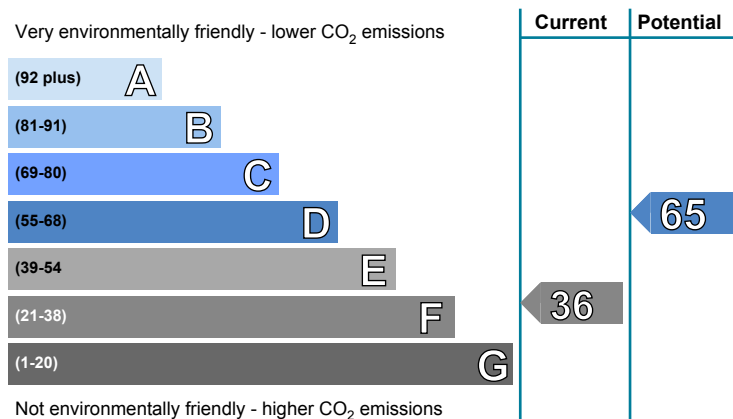
## Environmental Impact (CO<sub>2</sub>) Rating

This graph shows the effect of your home on the environment in terms of carbon dioxide (CO<sub>2</sub>) emissions. The higher the rating, the less impact it has on the environment.
