YOUR ONESURVEY
HOME REPORT

—
Omega
Leswalt High Road
Stranraer
DG9 0AA

SINGLE SURVEY

Single Survey

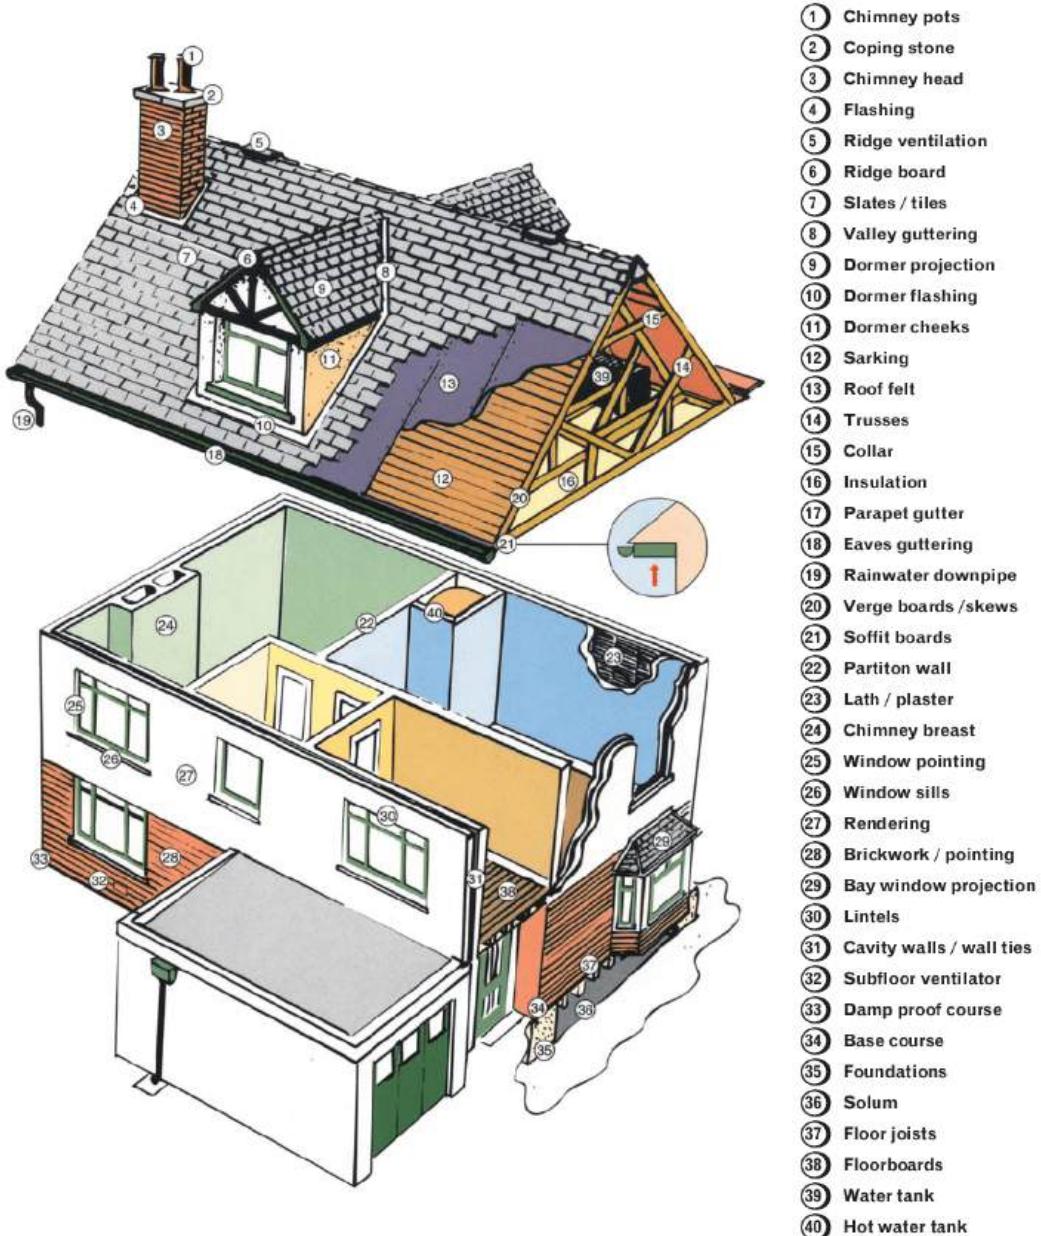
Sectional Diagram showing elements of a typical house

Reference may be made in this report to some or all of the above component parts of the property. This diagram may assist you in locating and understanding these items.

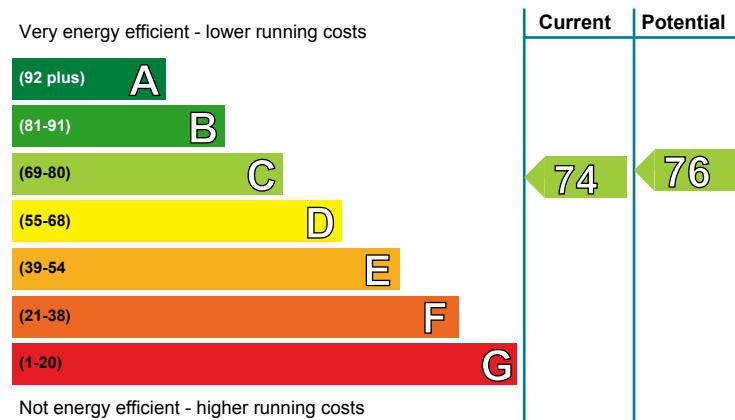
Energy Efficiency Rating

This graph shows the current efficiency of your home, taking into account both energy efficiency and fuel costs. The higher this rating, the lower your fuel bills are likely to be.

Your current rating is **band C (74)**. The average rating for EPCs in Scotland is **band D (61)**.

The potential rating shows the effect of undertaking all of the improvement measures listed within your recommendations report.

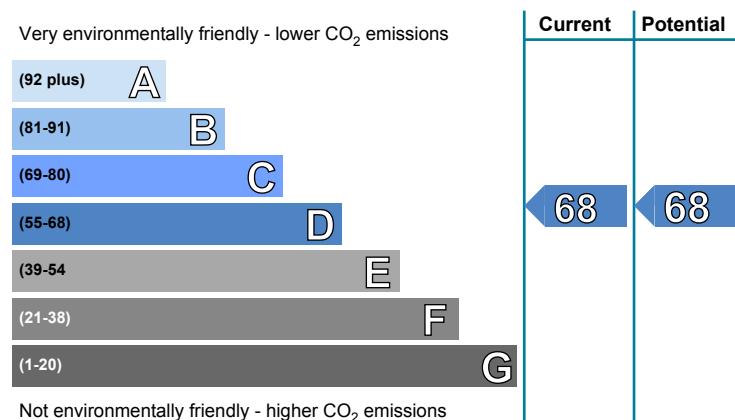
Environmental Impact (CO₂) Rating

This graph shows the effect of your home on the environment in terms of carbon dioxide (CO₂) emissions. The higher the rating, the less impact it has on the environment.
