# Home Report

# Single Survey

<b>Property address</b>	Station House Lindores Cupar KY14 6JD
<b>Customer</b>	Hanne Kosinowski and Andrew Grassie
<b>Customer address</b>	
<b>Prepared by</b>	Shepherd Chartered Surveyors
<b>Date of inspection</b>	03/05/2024

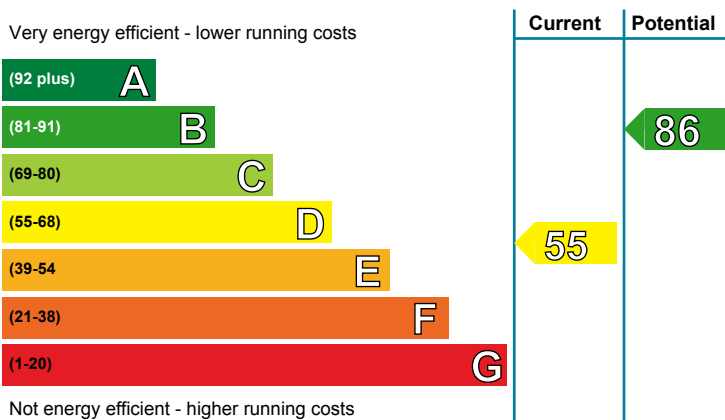
## Energy Efficiency Rating

This graph shows the current efficiency of your home, taking into account both energy efficiency and fuel costs. The higher this rating, the lower your fuel bills are likely to be.

Your current rating is **band D (55)**. The average rating for EPCs in Scotland is **band D (61)**.

The potential rating shows the effect of undertaking all of the improvement measures listed within your recommendations report.

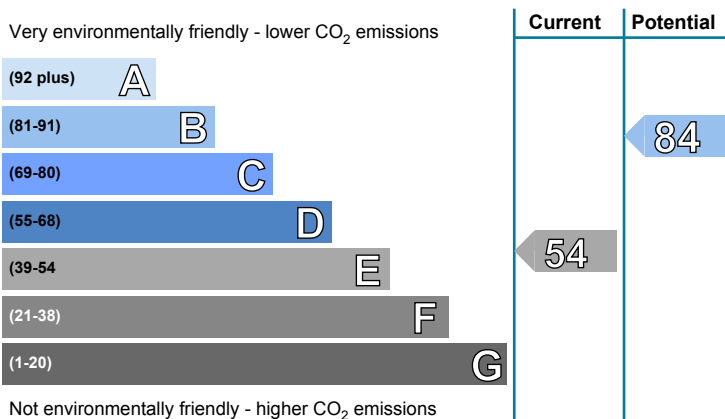
## Environmental Impact (CO<sub>2</sub>) Rating

This graph shows the effect of your home on the environment in terms of carbon dioxide (CO<sub>2</sub>) emissions. The higher the rating, the less impact it has on the environment.
