YOUR ONESURVEY
HOME REPORT

3 Blair of Tynet Cottage
Buckie
AB56 5HH

HOME REPORT

Single Survey

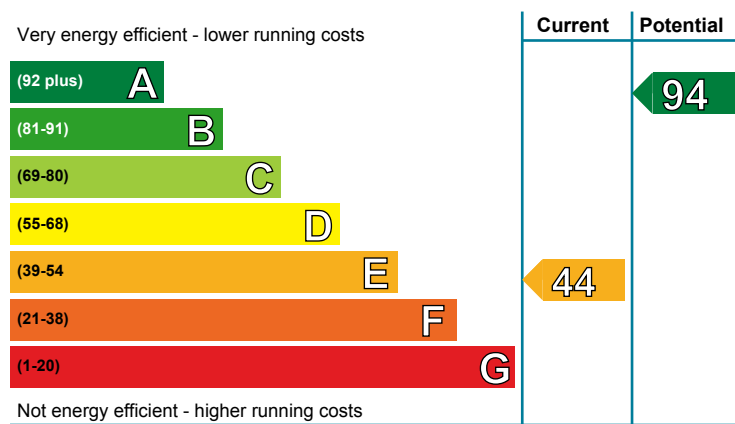
Energy Efficiency Rating

This graph shows the current efficiency of your home, taking into account both energy efficiency and fuel costs. The higher this rating, the lower your fuel bills are likely to be.

Your current rating is **band E (44)**. The average rating for EPCs in Scotland is **band D (61)**.

The potential rating shows the effect of undertaking all of the improvement measures listed within your recommendations report.

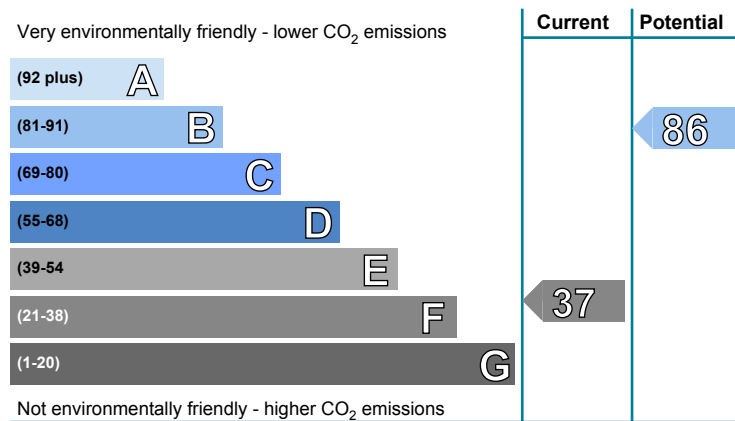
Environmental Impact (CO₂) Rating

This graph shows the effect of your home on the environment in terms of carbon dioxide (CO₂) emissions. The higher the rating, the less impact it has on the environment.
