YOUR ONESURVEY  
**HOME REPORT**

Burnside  
Glack of Clunymore  
Keith  
AB55 5JR

# SINGLE SURVEY

# Single Survey

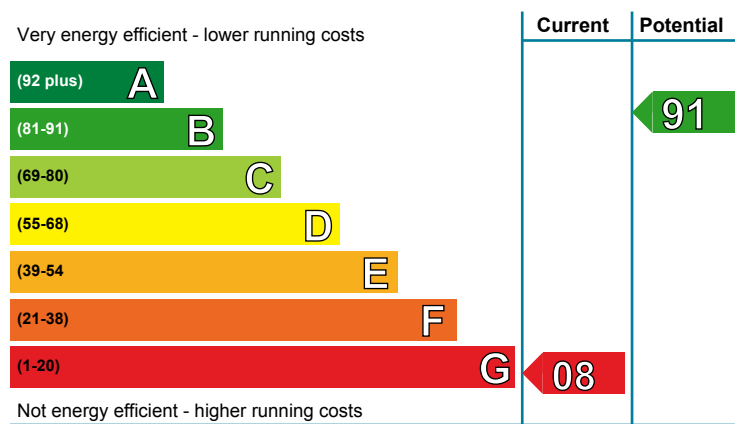
## Energy Efficiency Rating

This graph shows the current efficiency of your home, taking into account both energy efficiency and fuel costs. The higher this rating, the lower your fuel bills are likely to be.

Your current rating is **band G (8)**. The average rating for EPCs in Scotland is **band D (61)**.

The potential rating shows the effect of undertaking all of the improvement measures listed within your recommendations report.

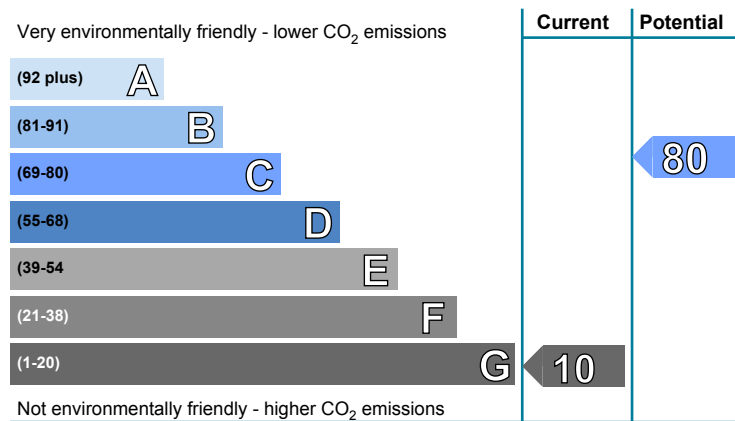
## Environmental Impact (CO<sub>2</sub>) Rating

This graph shows the effect of your home on the environment in terms of carbon dioxide (CO<sub>2</sub>) emissions. The higher the rating, the less impact it has on the environment.
