Home Report

Scottish Single Survey

Single Survey

Property address	Achnashelloch Lochgilphead PA31 8RE
Customer	Mr Douglas Campbell
Customer address	Achnashelloch Lochgilphead PA31 8RE
Prepared by	Shepherd Chartered Surveyors
Date of inspection	02/12/2025

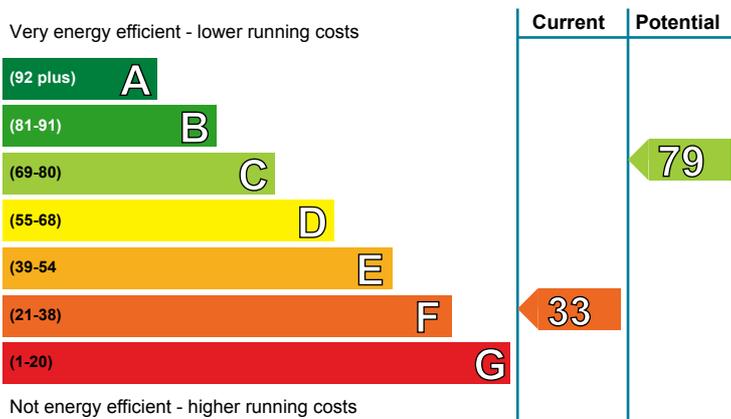
Energy Efficiency Rating

This graph shows the current efficiency of your home, taking into account both energy efficiency and fuel costs. The higher this rating, the lower your fuel bills are likely to be.

Your current rating is **band F (33)**. The average rating for EPCs in Scotland is **band D (61)**.

The potential rating shows the effect of undertaking all of the improvement measures listed within your recommendations report.

Estimated energy costs for your home for 3 years*	£21,858	See your recommendations report for more information
Over 3 years you could save*	£10,362

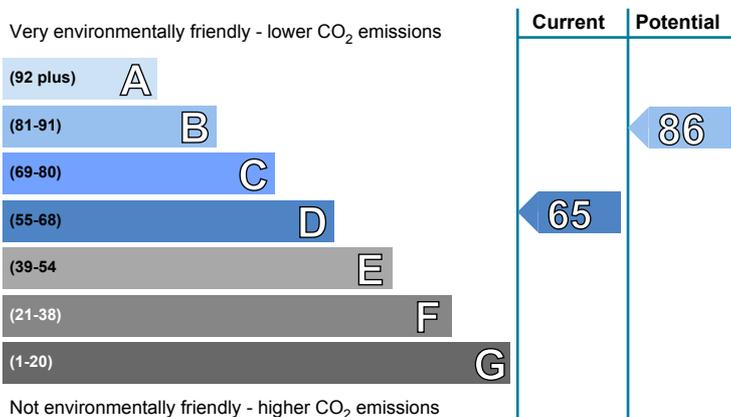
Environmental Impact (CO₂) Rating

This graph shows the effect of your home on the environment in terms of carbon dioxide (CO₂) emissions. The higher the rating, the less impact it has on the environment.
