YOUR ONESURVEY
HOME REPORT

Cockmuir House
Longmorn, Elgin
IV30 8SL

SINGLE SURVEY

Single Survey

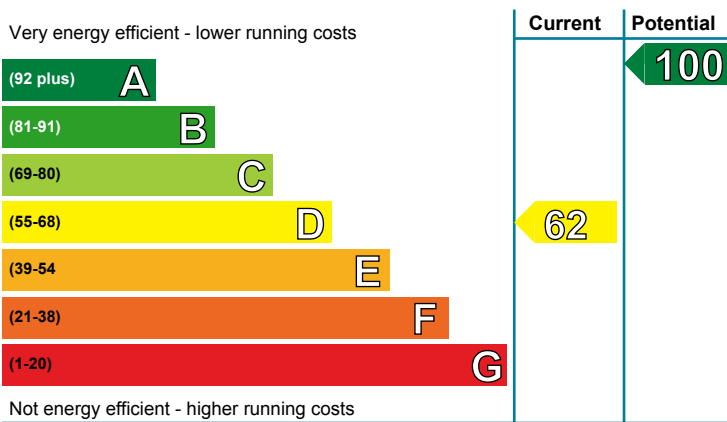
Energy Efficiency Rating

This graph shows the current efficiency of your home, taking into account both energy efficiency and fuel costs. The higher this rating, the lower your fuel bills are likely to be.

Your current rating is **band D (62)**. The average rating for EPCs in Scotland is **band D (61)**.

The potential rating shows the effect of undertaking all of the improvement measures listed within your recommendations report.

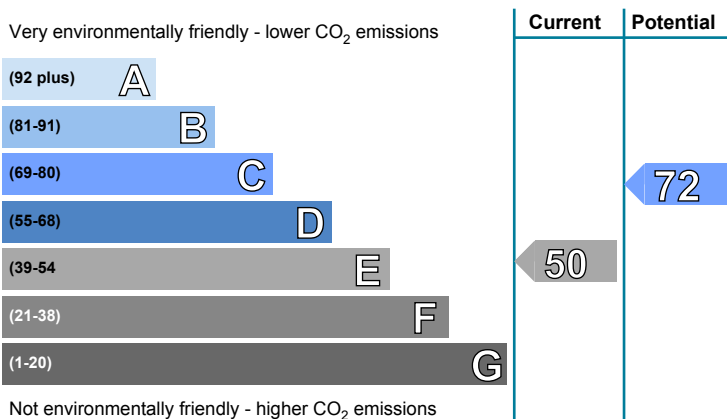
Environmental Impact (CO₂) Rating

This graph shows the effect of your home on the environment in terms of carbon dioxide (CO₂) emissions. The higher the rating, the less impact it has on the environment.
