HOME REPORT

NEW MAINS OF EDINGARIOCH PREMAY

INSCH
AB52 6PL

Energy Performance Certificate (EPC)

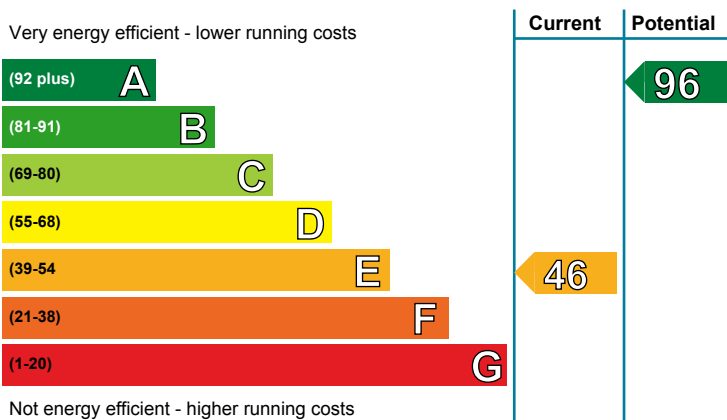
Energy Efficiency Rating

This graph shows the current efficiency of your home, taking into account both energy efficiency and fuel costs. The higher this rating, the lower your fuel bills are likely to be.

Your current rating is **band E (46)**. The average rating for EPCs in Scotland is **band D (61)**.

The potential rating shows the effect of undertaking all of the improvement measures listed within your recommendations report.

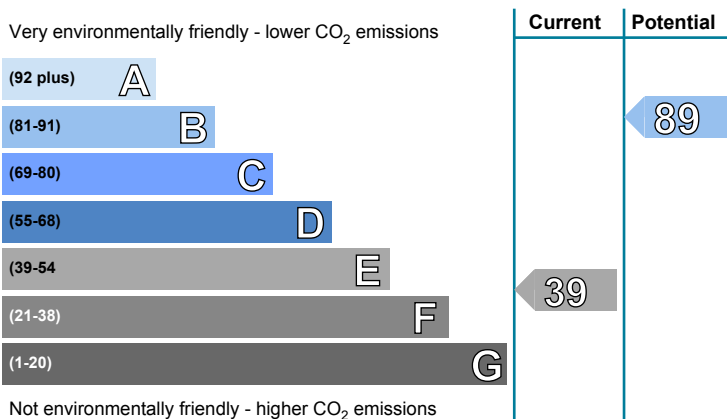
Environmental Impact (CO₂) Rating

This graph shows the effect of your home on the environment in terms of carbon dioxide (CO₂) emissions. The higher the rating, the less impact it has on the environment.

Your current rating is **band E (39)**. The average rating for EPCs in Scotland is **band D (59)**.

The potential rating shows the effect of undertaking all of the improvement measures listed within your recommendations report.
