Home Report

Single Survey

Property address	1 Wester Kinleith Farm Cottages Currie EH14 6AT
-------------------------	---

Prepared by	Shepherd Chartered Surveyors
--------------------	------------------------------

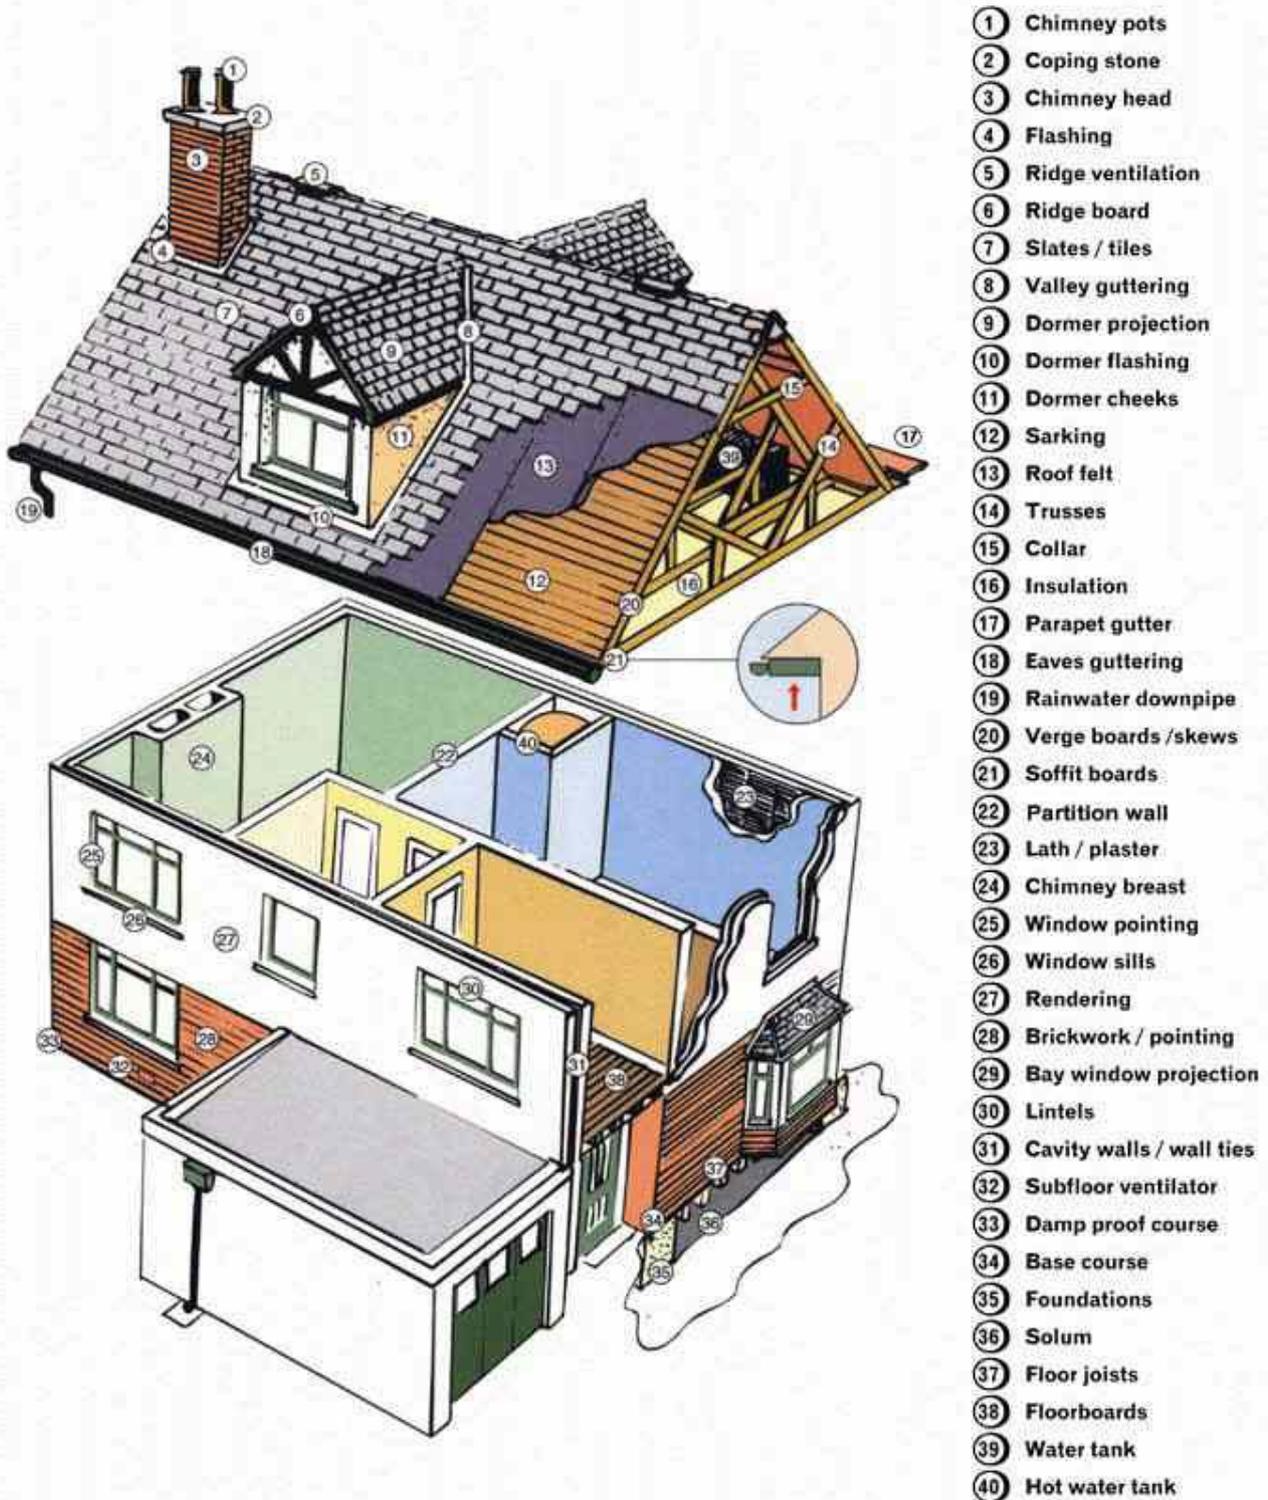
Sectional Diagram showing elements of a typical house

Reference may be made in this report to some or all of the above component parts of the property. This diagram may assist you in locating and understanding these items.

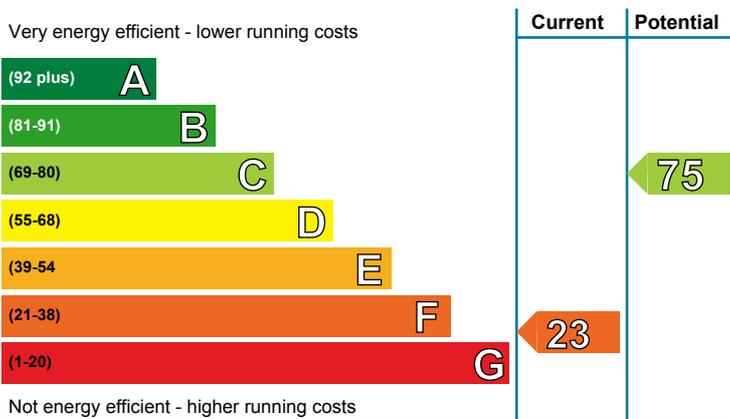
Energy Efficiency Rating

This graph shows the current efficiency of your home, taking into account both energy efficiency and fuel costs. The higher this rating, the lower your fuel bills are likely to be.

Your current rating is **band F (23)**. The average rating for EPCs in Scotland is **band D (61)**.

The potential rating shows the effect of undertaking all of the improvement measures listed within your recommendations report.

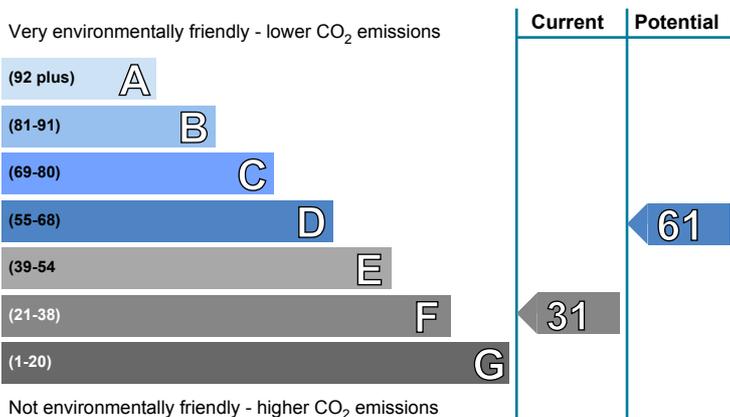
Environmental Impact (CO₂) Rating

This graph shows the effect of your home on the environment in terms of carbon dioxide (CO₂) emissions. The higher the rating, the less impact it has on the environment.
