# HOME REPORT

KIRKHOLM  
15 BRIDGE STREET  
SALINE  
DUNFERMLINE  
KY12 9TS

KIRKHOLM, 15 BRIDGE STREET, SALINE, DUNFERMLINE, KY12 9TS

**Dwelling type:** Detached house  
**Date of assessment:** 01 February 2023  
**Date of certificate:** 02 February 2023  
**Total floor area:** 394 m<sup>2</sup>  
**Primary Energy Indicator:** 266 kWh/m<sup>2</sup>/year

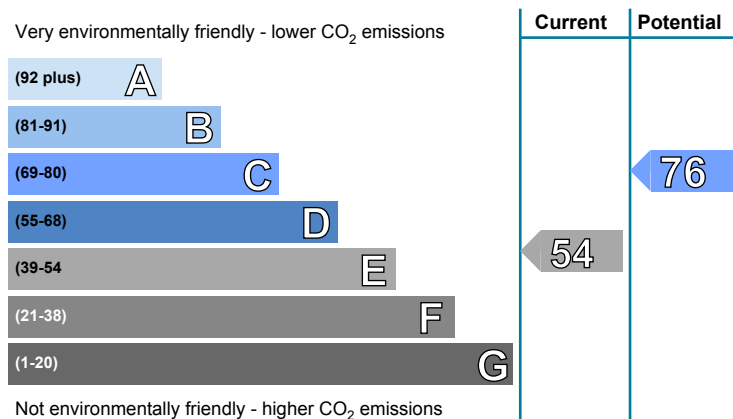
## Environmental Impact (CO<sub>2</sub>) Rating

This graph shows the effect of your home on the environment in terms of carbon dioxide (CO<sub>2</sub>) emissions. The higher the rating, the less impact it has on the environment.

Your current rating is **band E (54)**. The average rating for EPCs in Scotland is **band D (59)**.

The potential rating shows the effect of undertaking all of the improvement measures listed within your recommendations report.
