Sheraig,
Killochries Road,
Kilmacolm,
Renfrewshire,
PA13 4TE

Home Report

Single Survey

Property Address	Sheraig, Killochries Road, Kilmacolm, Renfrewshire, PA13 4TE
Reference	1333285
Customer Name	Iain & Sheena Graham
Date of Inspection	4th December 2025
Surveyor's name, qualifications and office	David Cree BSc, MRICS DM Hall LLP Chartered Surveyors 3 Centura Court, Hillington Park Glasgow G52 4PR Tel: 0141 636 4141 email: glasgowresidential@dmhall.co.uk
Prepared By	DM Hall LLP

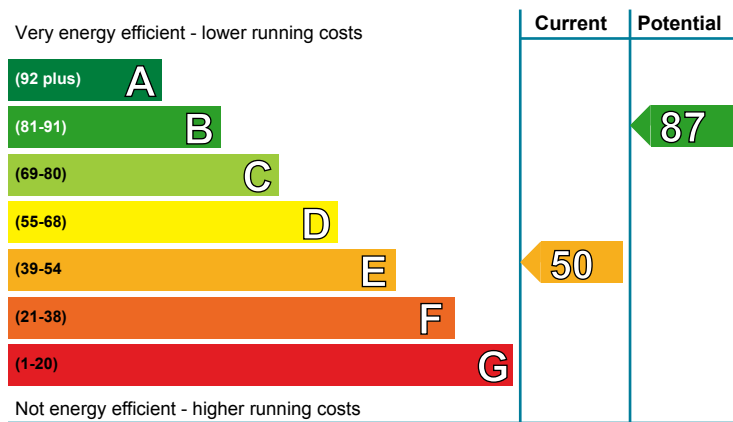
Energy Efficiency Rating

This graph shows the current efficiency of your home, taking into account both energy efficiency and fuel costs. The higher this rating, the lower your fuel bills are likely to be.

Your current rating is **band E (50)**. The average rating for EPCs in Scotland is **band D (61)**.

The potential rating shows the effect of undertaking all of the improvement measures listed within your recommendations report.

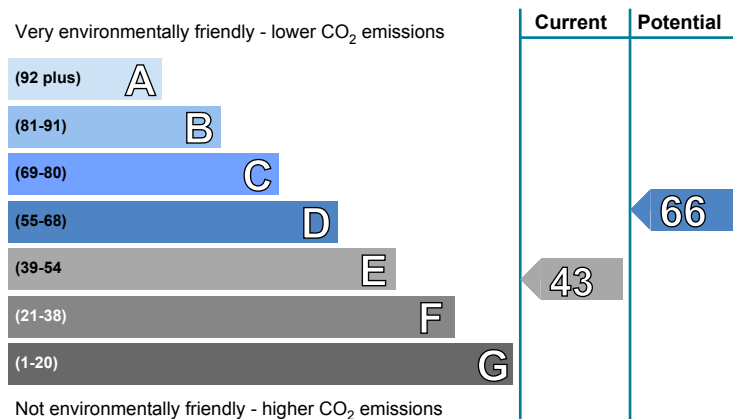
Environmental Impact (CO₂) Rating

This graph shows the effect of your home on the environment in terms of carbon dioxide (CO₂) emissions. The higher the rating, the less impact it has on the environment.
