# Home Report

# Single Survey

<b>Property address</b>	Fodderty Lodge Dingwall IV15 9UE
<b>Customer</b>	Colin Coutts & Mia Sabel
<b>Customer address</b>	Fodderty Lodge Dingwall IV15 9UE
<b>Prepared by</b>	Shepherd Chartered Surveyors
<b>Date of inspection</b>	02/06/2025

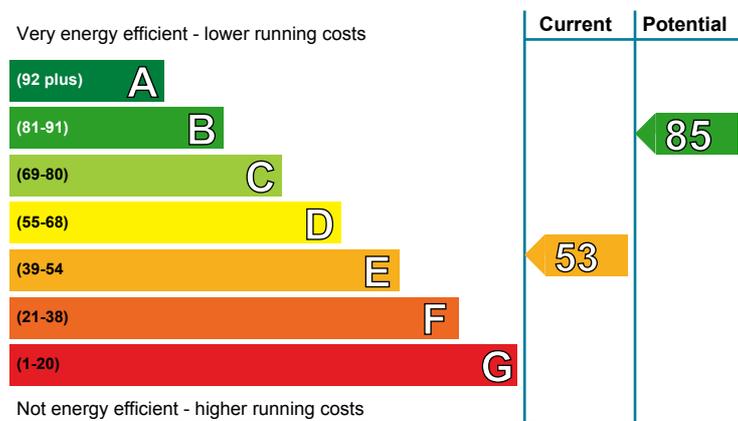
## Energy Efficiency Rating

This graph shows the current efficiency of your home, taking into account both energy efficiency and fuel costs. The higher this rating, the lower your fuel bills are likely to be.

Your current rating is **band E (53)**. The average rating for EPCs in Scotland is **band D (61)**.

The potential rating shows the effect of undertaking all of the improvement measures listed within your recommendations report.

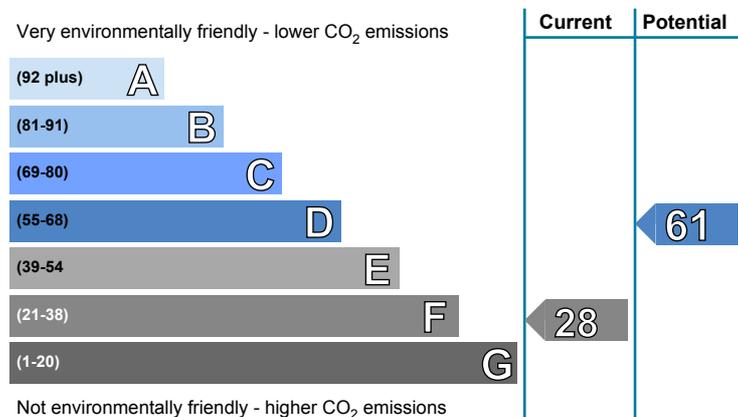
## Environmental Impact (CO<sub>2</sub>) Rating

This graph shows the effect of your home on the environment in terms of carbon dioxide (CO<sub>2</sub>) emissions. The higher the rating, the less impact it has on the environment.
