HOME REPORT

Energy Performance Certificate (EPC)

ORCHARDKNOWES, KIPPFORD, DALBEATTIE, DG5 4LG

Dwelling type: Detached house
Date of assessment: 26 April 2022
Date of certificate: 03 May 2022
Total floor area: 297 m²
Primary Energy Indicator: 352 kWh/m²/year

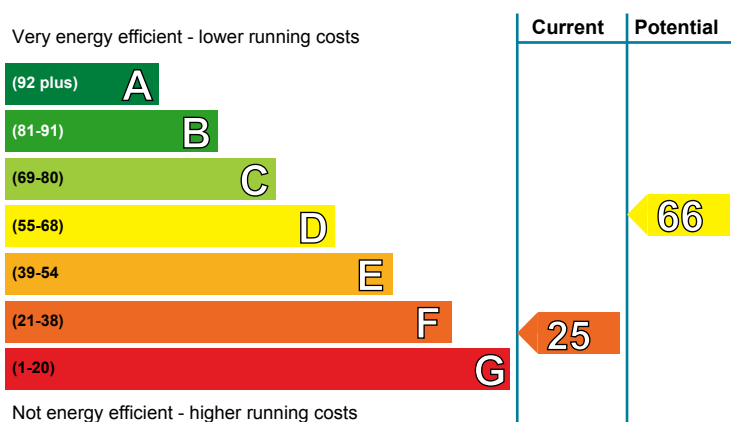
Energy Efficiency Rating

This graph shows the current efficiency of your home, taking into account both energy efficiency and fuel costs. The higher this rating, the lower your fuel bills are likely to be.

Your current rating is **band F (25)**. The average rating for EPCs in Scotland is **band D (61)**.

The potential rating shows the effect of undertaking all of the improvement measures listed within your recommendations report.

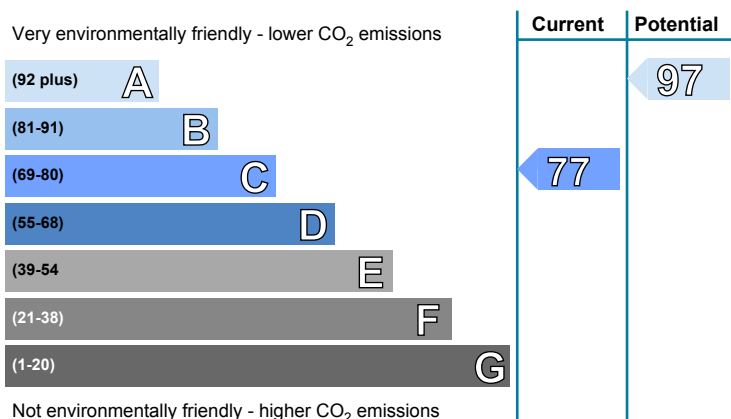
Environmental Impact (CO₂) Rating

This graph shows the effect of your home on the environment in terms of carbon dioxide (CO₂) emissions. The higher the rating, the less impact it has on the environment.

Your current rating is **band C (77)**. The average rating for EPCs in Scotland is **band D (59)**.

The potential rating shows the effect of undertaking all of the improvement measures listed within your recommendations report.

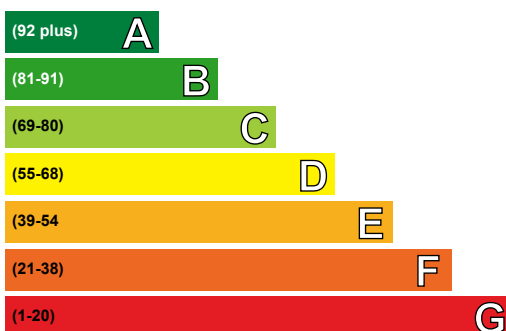
Very energy efficient - lower running costs

Not energy efficient - higher running costs

Current	Potential
	112
50

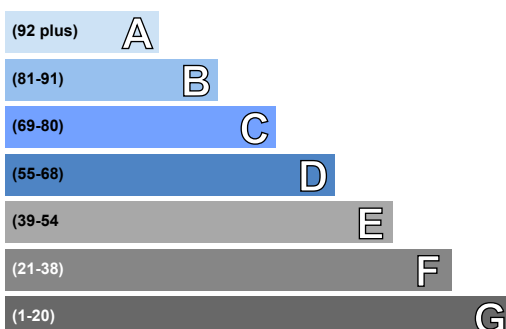
Very environmentally friendly - lower CO₂ emissions

Not environmentally friendly - higher CO₂ emissions

Current	Potential
91	125
