# Home Report

Steading Cottage Islabank Farm Coupar Angus PH13 9HJ

# single survey

## survey report on:

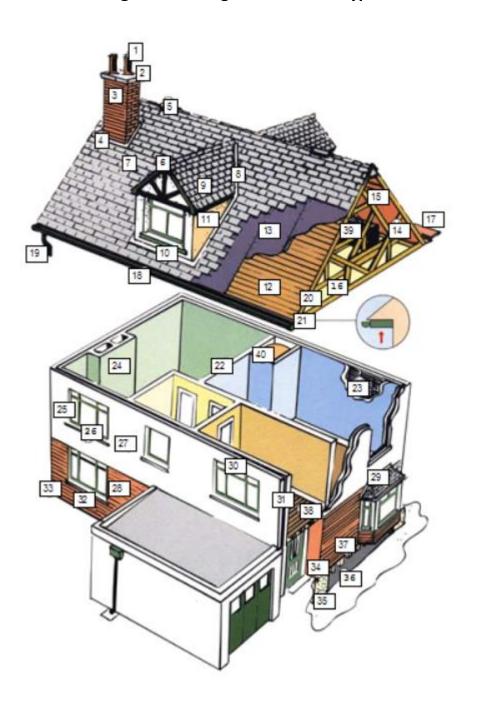
#### Sectional Diagram showing elements of a typical house

Chimney pots Coping stone 3 Chimney head **Flashing** Ridge ventilation Ridge board Slates/tiles Valley guttering Dormer projection 10 Dormer flashing 11 Dormer cheeks 12 Sarking 13 Roof felt 14 Trusses 15 Collar 16 Insulation 17 Parapet gutter 18 Eaves guttering 19 Rainwater downpipe 20 Verge boards / skews 21 Soffit boards 22 Partition wall 23 Lath / plaster 24 Chimney breast 25 Window pointing 26 Window sills 27 Rendering 28 Brickwork / pointing 29 Bay window 30 Lintels 31 Cavity walls / wall ties 32 Subfloor ventilator 33 Damp proof course 34 Base course 35 **Foundations** 36 Solum
