**Walker Fraser Steele**  
**Chartered Surveyors**

## Energy Performance Certificate

**BANKHEAD, FORDOUN, LAURENCEKIRK, AB30 1LN**

**Dwelling type:** Detached house  
**Date of assessment:** 05 July 2023  
**Date of certificate:** 05 July 2023  
**Total floor area:** 200 m<sup>2</sup>  
**Primary Energy Indicator:** 365 kWh/m<sup>2</sup>/year

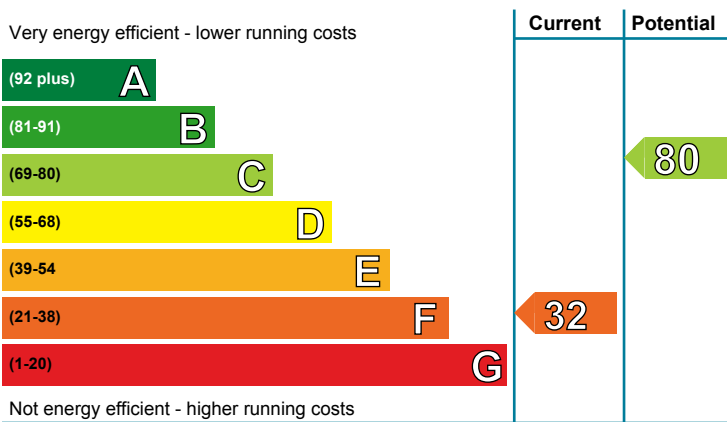
## Energy Efficiency Rating

This graph shows the current efficiency of your home, taking into account both energy efficiency and fuel costs. The higher this rating, the lower your fuel bills are likely to be.

Your current rating is **band F (32)**. The average rating for EPCs in Scotland is **band D (61)**.

The potential rating shows the effect of undertaking all of the improvement measures listed within your recommendations report.

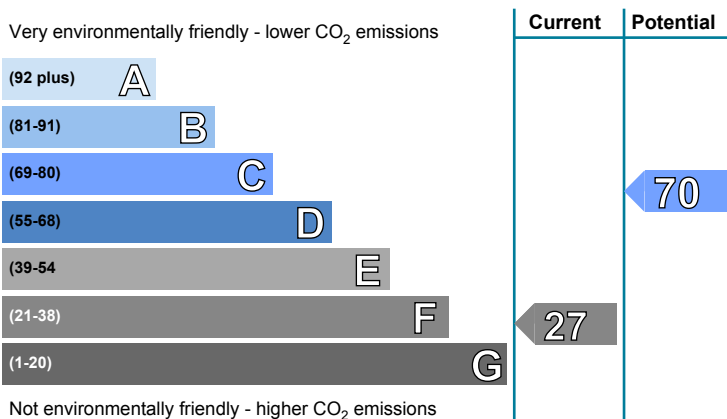
## Environmental Impact (CO<sub>2</sub>) Rating

This graph shows the effect of your home on the environment in terms of carbon dioxide (CO<sub>2</sub>) emissions. The higher the rating, the less impact it has on the environment.

Your current rating is **band F (27)**. The average rating for EPCs in Scotland is **band D (59)**.

The potential rating shows the effect of undertaking all of the improvement measures listed within your recommendations report.
