# Home Report

# Scottish Single Survey

Property address	Dalmorton House Straiton Maybole KA19 7NN
Customer	Mr G Marshall
Customer address	Dalmorton House Straiton Maybole KA19 7NN
Prepared by	Shepherd Chartered Surveyors
Date of inspection	29/04/2024

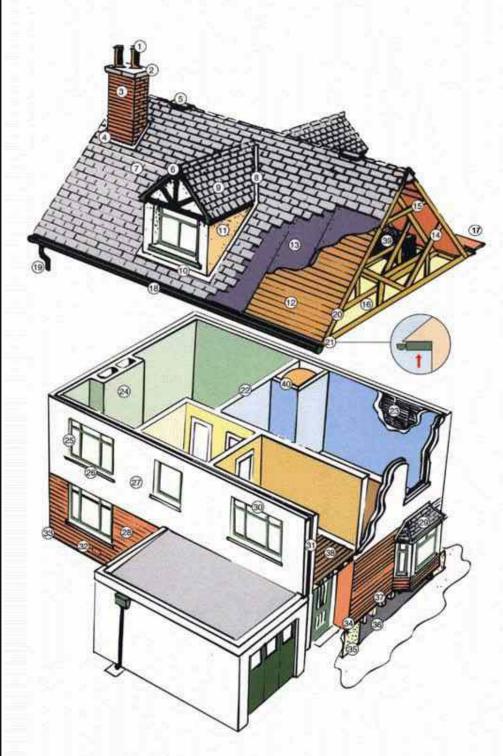
### Sectional Diagram showing elements of a typical house

Reference may be made in this report to some or all of the above component parts of the property. This diagram may assist you in locating and understanding these items.

- 1) Chimney pots
- 2) Coping stone
- 3 Chimney head
- (4) Flashing
- 5) Ridge ventilation
- 6) Ridge board
- 7 Slates / tiles
- 8 Valley guttering
- 9 Dormer projection
- 10 Dormer flashing
- 11 Dormer cheeks
- 12) Sarking
- 13) Roof felt
- (14) Trusses
- (15) Collar
- 16) Insulation
- (17) Parapet gutter
- 18) Eaves guttering
- (19) Rainwater downpipe
- 20) Verge boards/skews
- 21) Soffit boards
- 22) Partition wall
- 23) Lath / plaster
- (24) Chimney breast
- 25) Window pointing
- 26) Window sills
- 27) Rendering
- (28) Brickwork / pointing
- 29 Bay window projection
- (30) Lintels
- (31) Cavity walls / wall ties
- 32) Subfloor ventilator
- (33) Damp proof course
- 34) Base course
- (35) Foundations
- 36) Solum
- 37) Floor joists
- 8) Floorboards
- 39) Water tank
- (40) Hot water tank
